#### **Uniform Mitigation Verification Inspection Form**

| Inspection Date: 10/11/2019 | | | | | |
| Address: 250 NE 20th St (East Building) | | Home Phone: (561) 392-1600 | | | |

## **Elevation Photos** 250 NE 20th St (East Building)

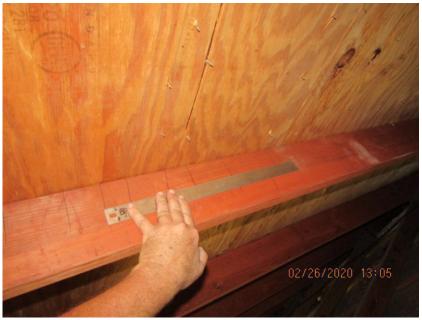
8d Nails or Greater in Size Spaced 6" Along the Edge

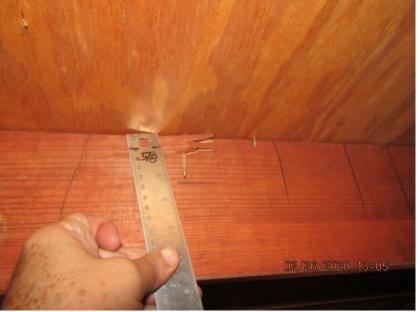
8d Nails or Greater in Size

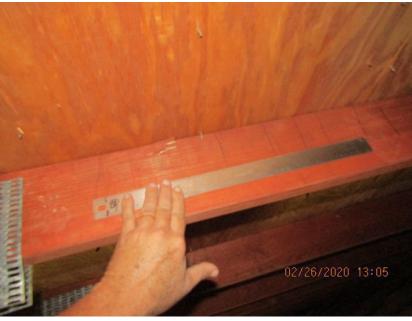
8d Nails or Greater in Size Spaced 6" in the Field

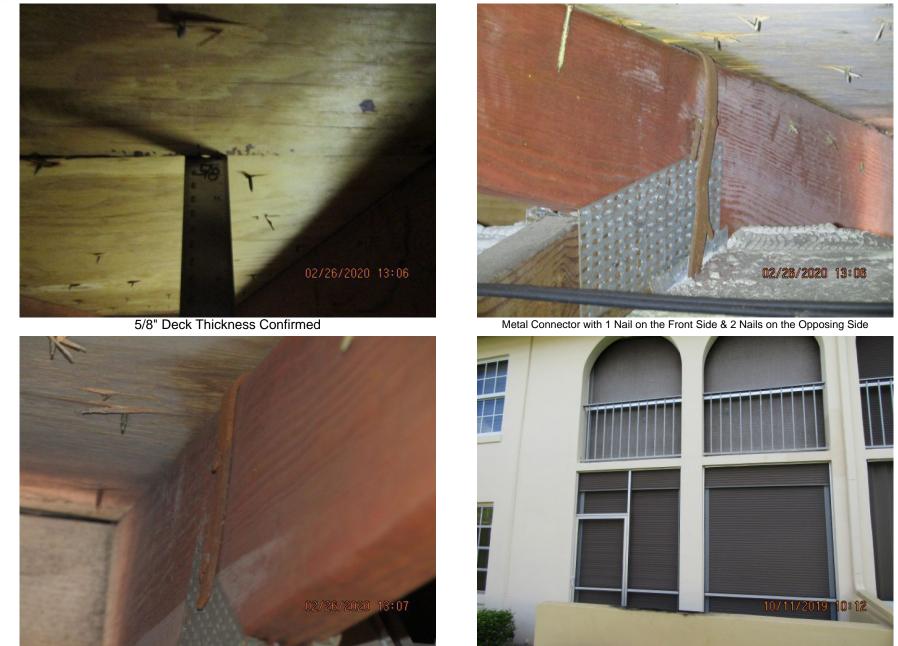
Metal Connector with 1 Nail on the Front Side & 2 Nails on the Opposing Side

Non-Impact Rated Roll Down Shutter

**Roof-to-Wall Attachment** Our report indicates that the existing roof-to-wall attachment(s) do not meet the requirements on the Uniform Mitigation Verification Inspection form for Single Wrap Straps. This definition requires at least two nails on the front side and at least one on the other of every strap in the attic, on every truss or rafter. As it is often difficult to access every truss or rafter, the ideal time to upgrade this feature is when the roof deck is being replaced. In some circumstances, this work can be done on its own; consult a professional for details. Retrofits to existing roof to wall connections should be permitted with the local building department, and installations should follow the manufacturer's guidelines.

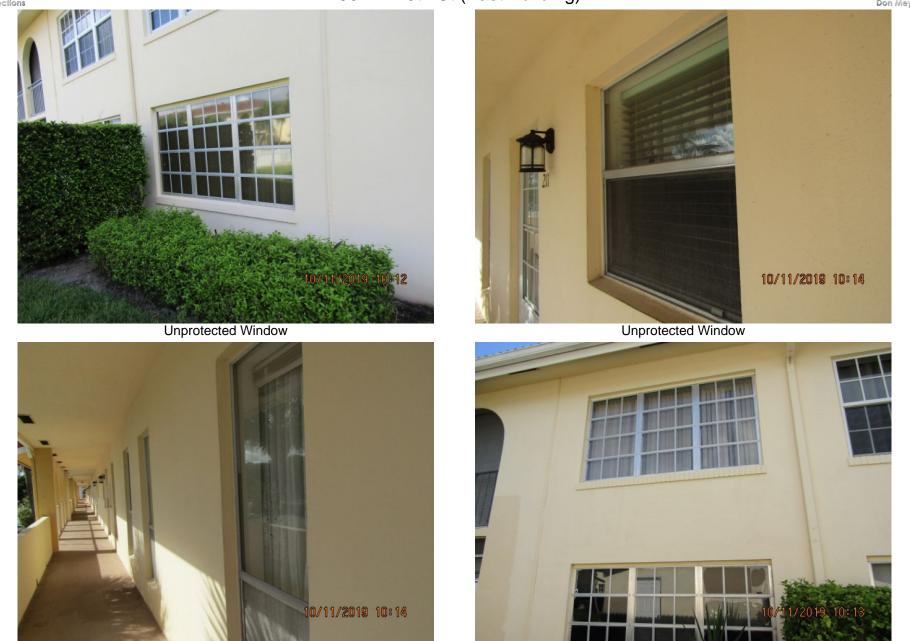
Unprotected Window

**Unprotected Windows**

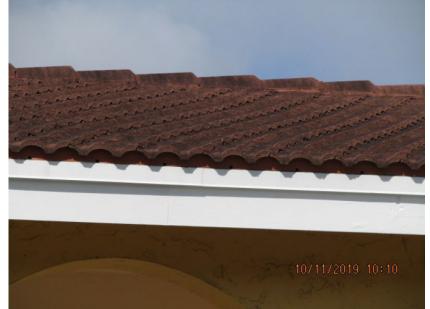
Concrete/Clay Tile Roof Covering
