Albanese Commerce Center C.A., Inc.
Boca Raton, FL

Report #: 48425-0
Beginning: January 1, 2024
Expires: December 31, 2024

RESERVE STUDY
"Full"

August 21, 2023

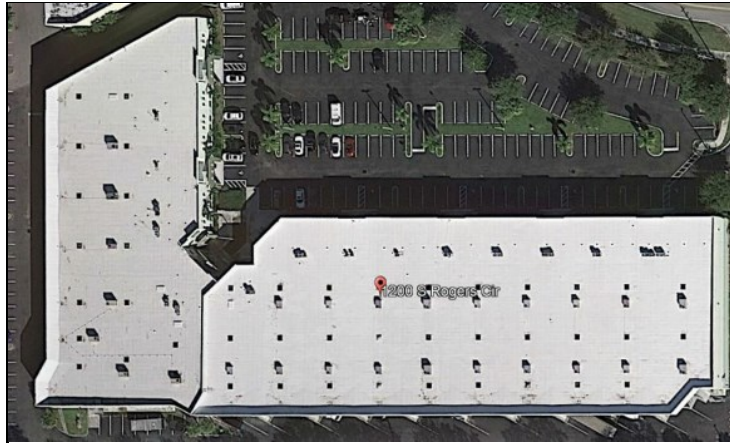
Useful Life:
20 years

Remaining Life:
7 years

Best Case: \$ 1,009,800

Worst Case: \$ 1,377,000

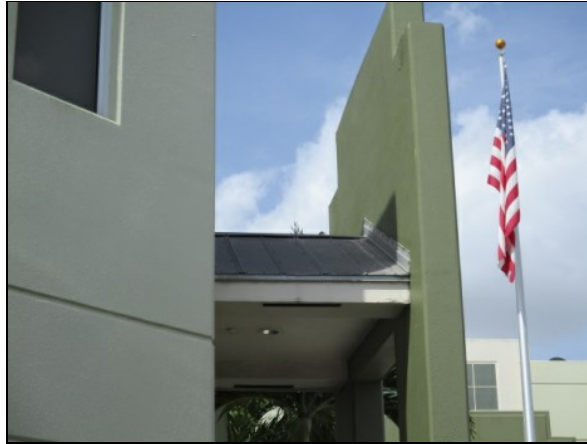
Useful Life:
30 years

Remaining Life:
8 years

Best Case: \$ 19,300

Worst Case: \$ 23,500

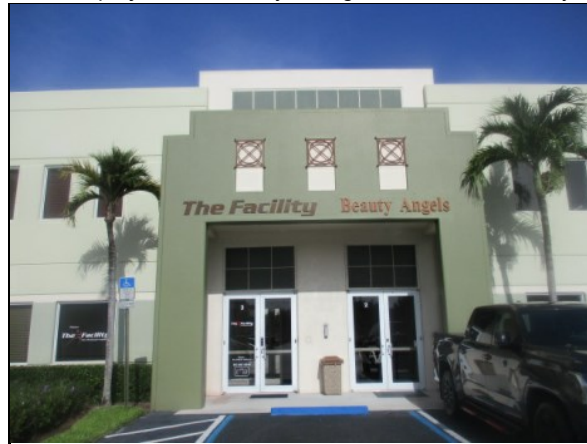
Remaining Life:

5 years

Best Case: \$ 47,300

Worst Case: \$ 57,900

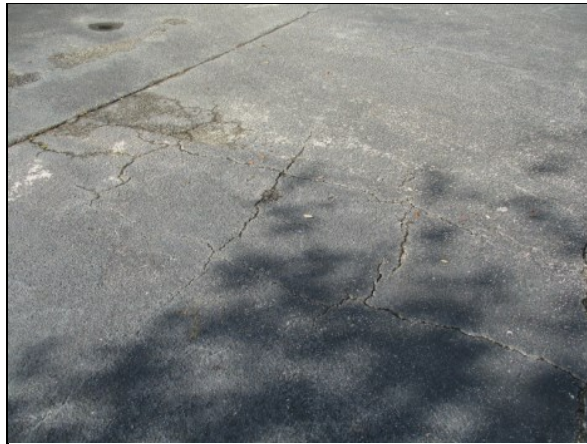
Useful Life:
5 years

Remaining Life:
1 years

Best Case: \$ 22,800

Worst Case: \$ 26,000

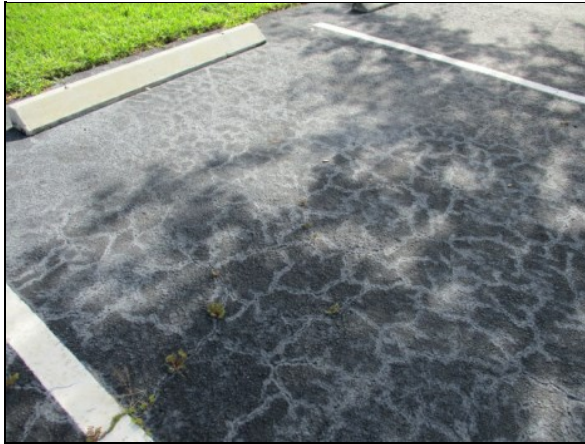
Useful Life:
20 years

Remaining Life:
0 years

Best Case: \$ 193,100

Worst Case: \$ 236,000

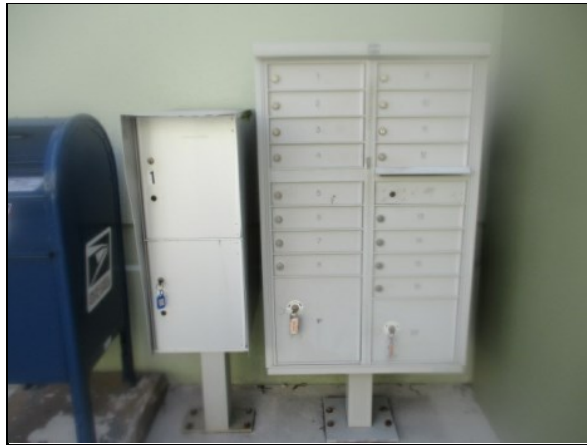
Useful Life:
20 years

Remaining Life:
5 years

Best Case: \$ 4,800

Worst Case: \$ 5,900

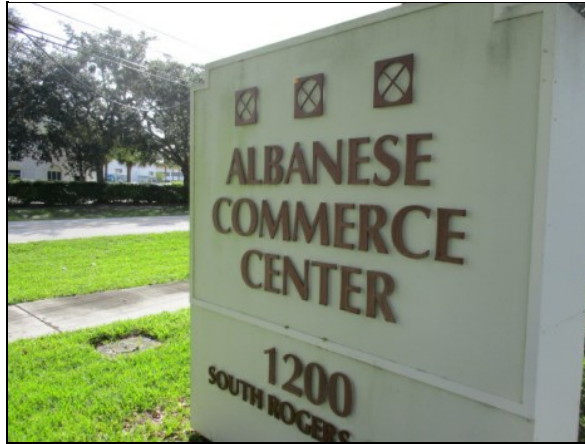
Useful Life:
20 years

Remaining Life:
2 years

Best Case: \$ 4,700

Worst Case: \$ 5,800

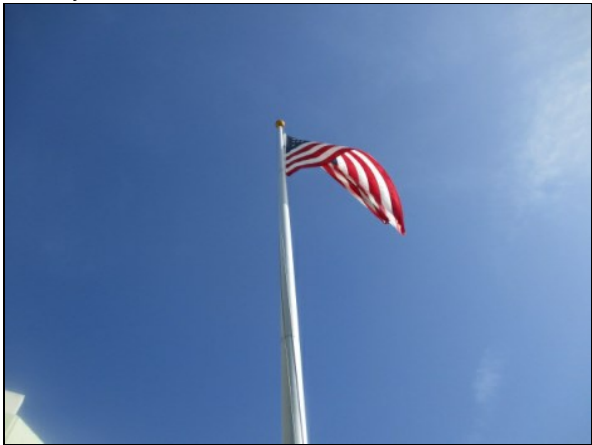
Useful Life:
30 years

Remaining Life:
16 years

Best Case: \$ 3,500

Worst Case: \$ 5,500

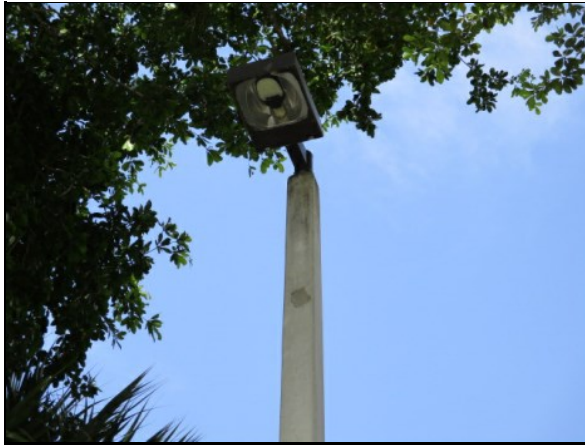
Useful Life:
15 years

Remaining Life:
8 years

Best Case: \$ 43,000

Worst Case: \$ 53,000

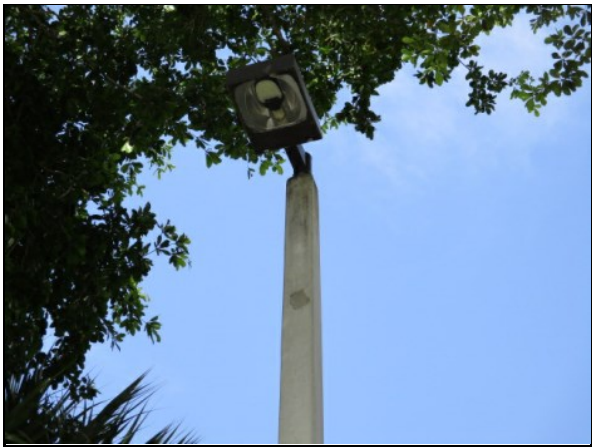
Useful Life:
45 years

Remaining Life:
23 years

Best Case: \$ 108,000

Worst Case: \$ 135,000

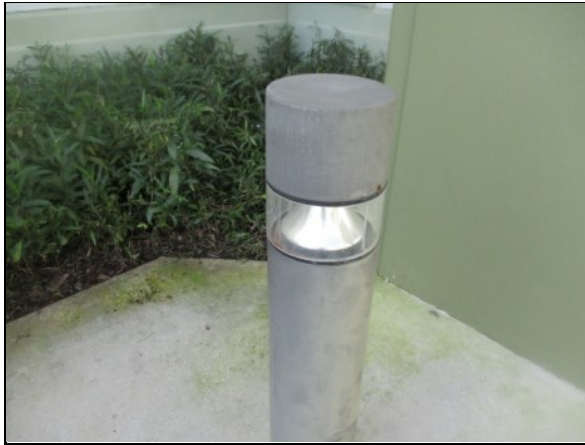
Useful Life:
20 years

Remaining Life:
0 years

Best Case: \$ 5,400

Worst Case: \$ 6,600

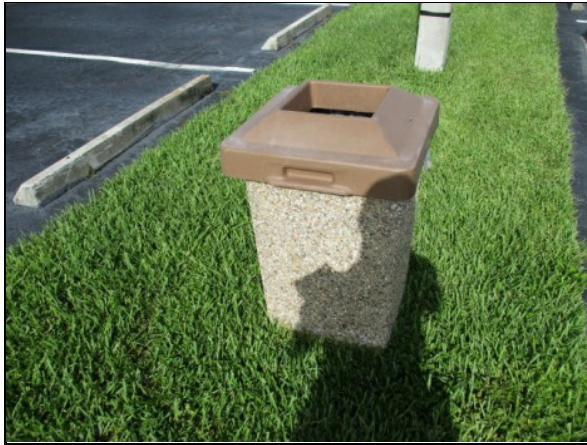
Useful Life:
15 years

Remaining Life:
4 years

Best Case: \$ 4,400

Worst Case: \$ 5,400

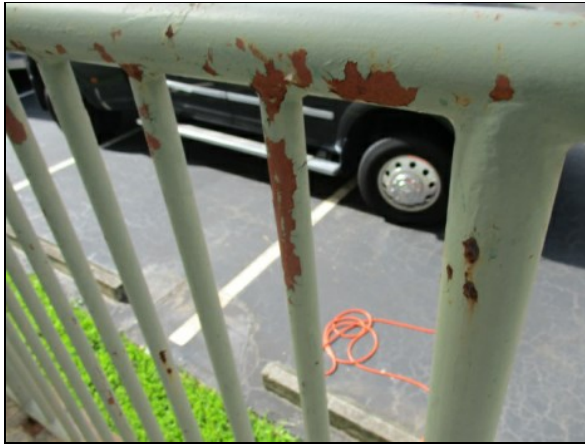
Useful Life:
30 years

Remaining Life:
8 years

Best Case: \$ 27,500

Worst Case: \$ 33,600

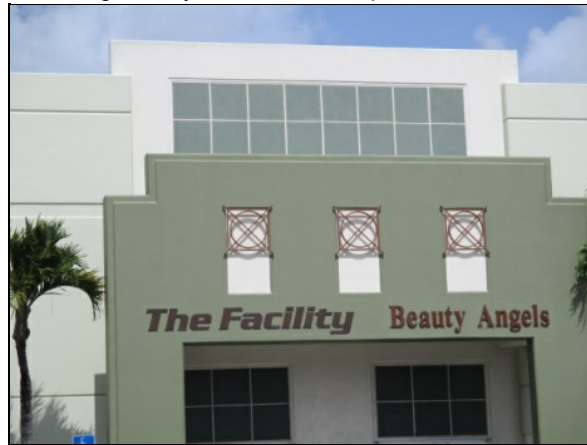
Useful Life:
30 years

Remaining Life:
8 years

Best Case: \$ 3,600

Worst Case: \$ 4,500

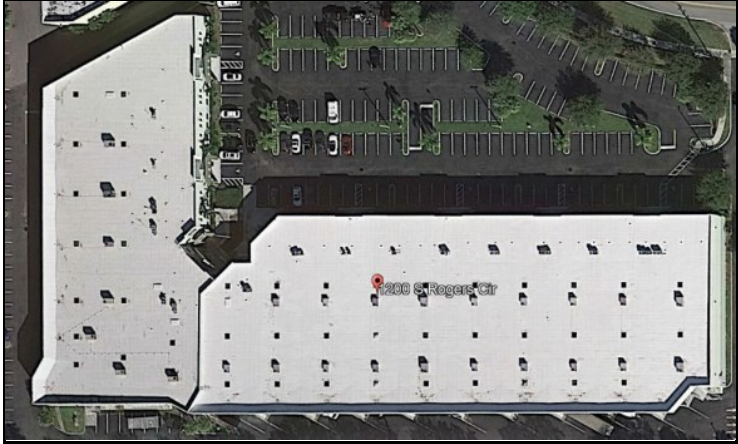
Useful Life:
30 years

Remaining Life:
7 years

Best Case: \$ 73,800

Worst Case: \$ 90,200

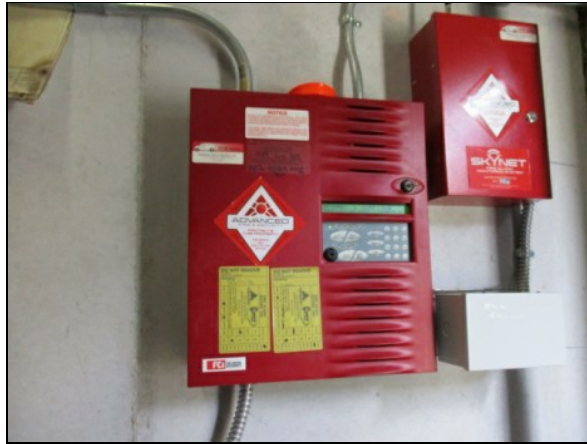
Useful Life:
25 years

Remaining Life:
3 years

Best Case: \$ 53,600

Worst Case: \$ 65,500
