A. T. DESIGNS, INC.

July 14, 2023

Re: Structural Evaluation and Milestone Inspection Report
Court of Delray Condominium
Delray Beach, Florida

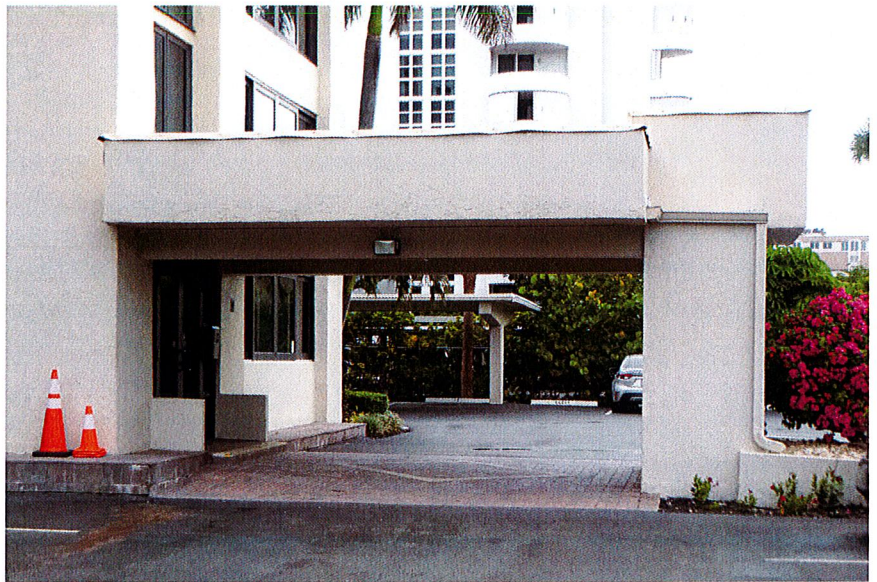
Photo 6: Photograph of the Typical Parking Structures located along the North, West, and South Portions of the Property.

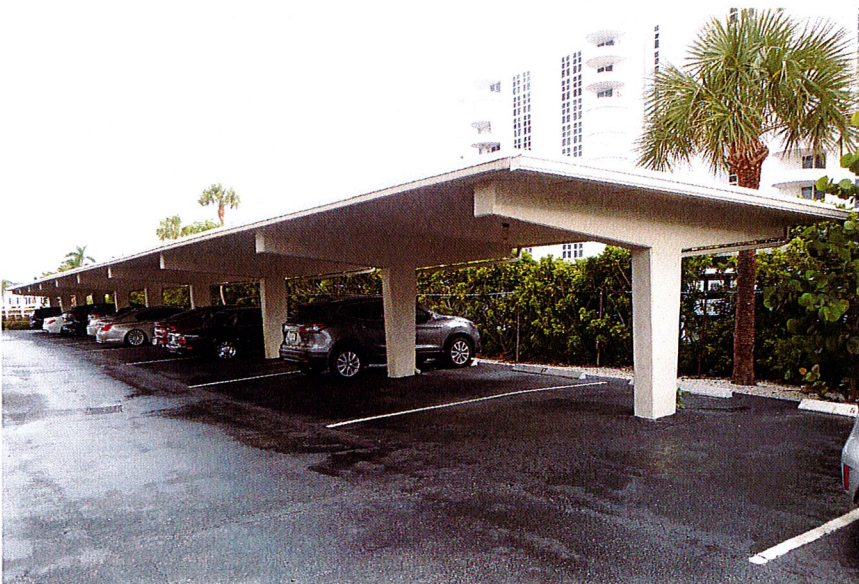
Photo 7: Close-up Photograph of the Typical Parking Structures which are comprised on Prestressed Concrete Roof Panels Supported by Concrete Support Structures.

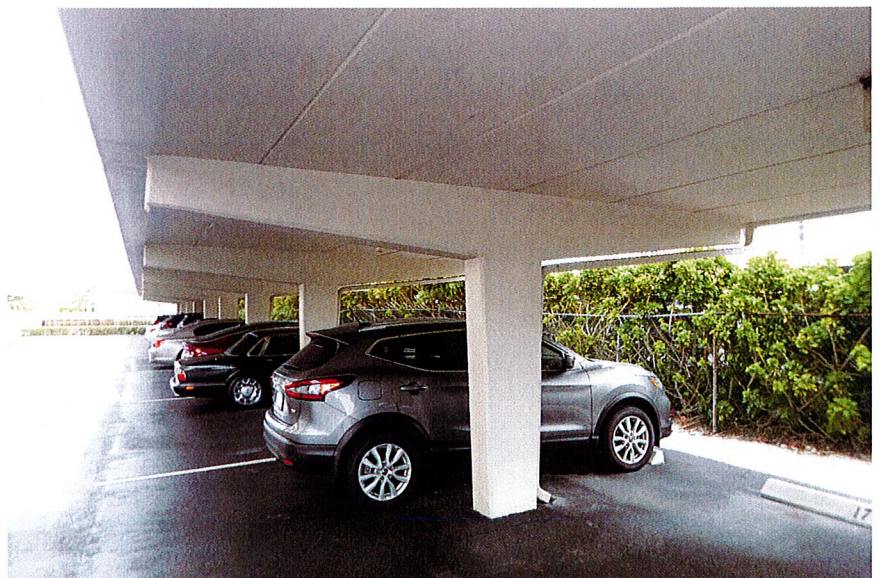
- i. The parking structures have experienced isolated deterioration of both the prestressed roof panels and the reinforced concrete support structures. There also minor typical degradation of the intersection of the prestressed panels at the termination of the reinforced concrete supporting members.

Photo 8: Photograph of the Typical Concrete Spall/Deterioration on the Undersided of a Prestressed Concrete Roof Panel.

- vi. The isolated areas of parking structures show signs of spalling and deterioration of the prestressed and cast-in-place reinforced concrete elements, which need to be addressed and repaired.

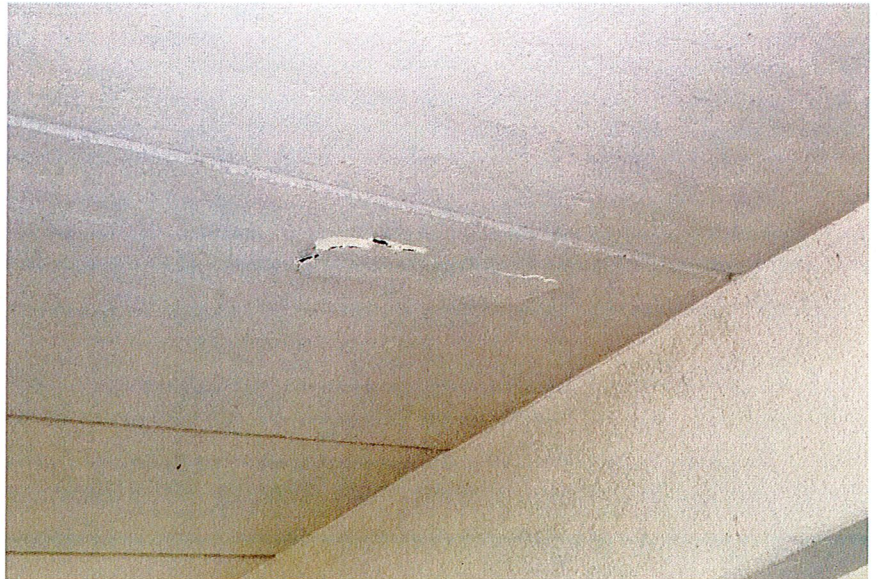
Photo 9: Photograph of a Typical Concrete Spall/Deterioration on the Underside of the Edge, Along the Intersection of the Prestressed Concrete Roof Panels.

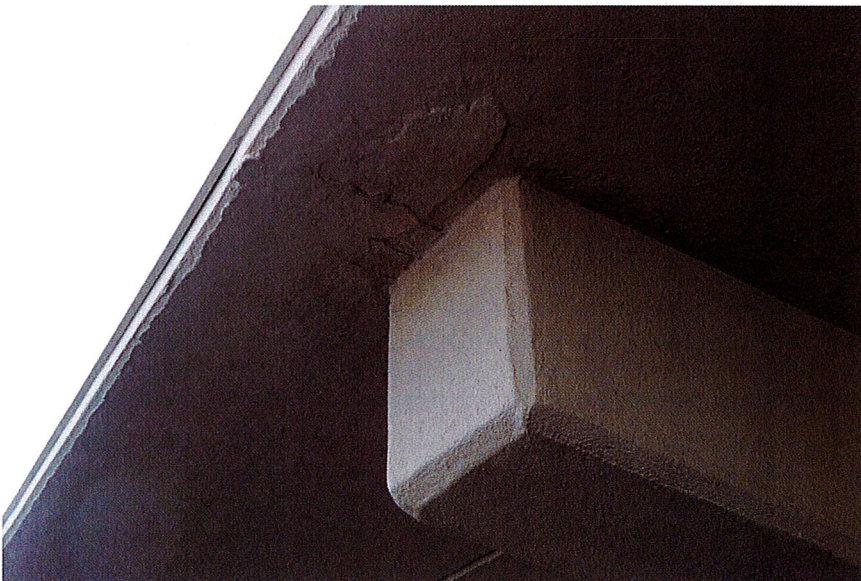
Photo 10: Photograph of a Concrete Spall/Deterioration on the side of the Concrete Supporting Structure.

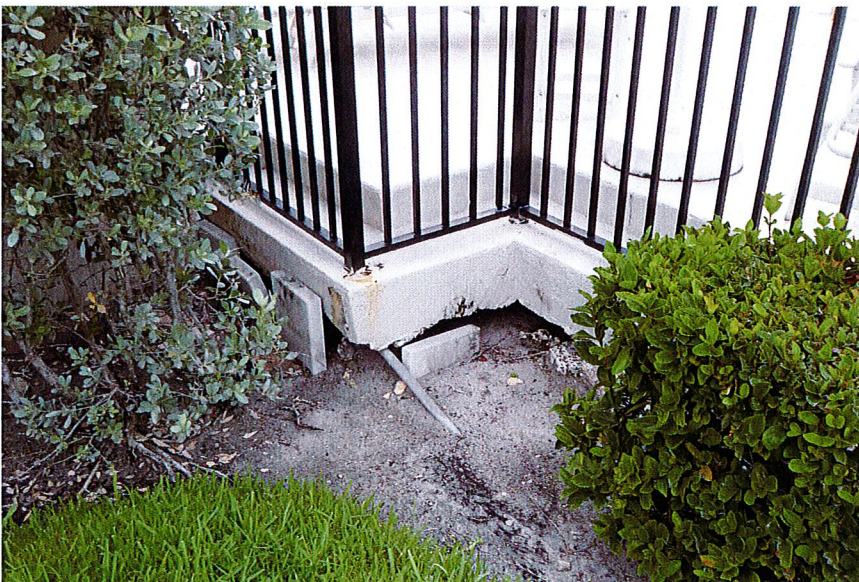
Photo 13: Photograph of the Placement of a concrete Step and Blocks to Cover the loss of Soil from Under the North Edge of the Concrete Pool Deck.

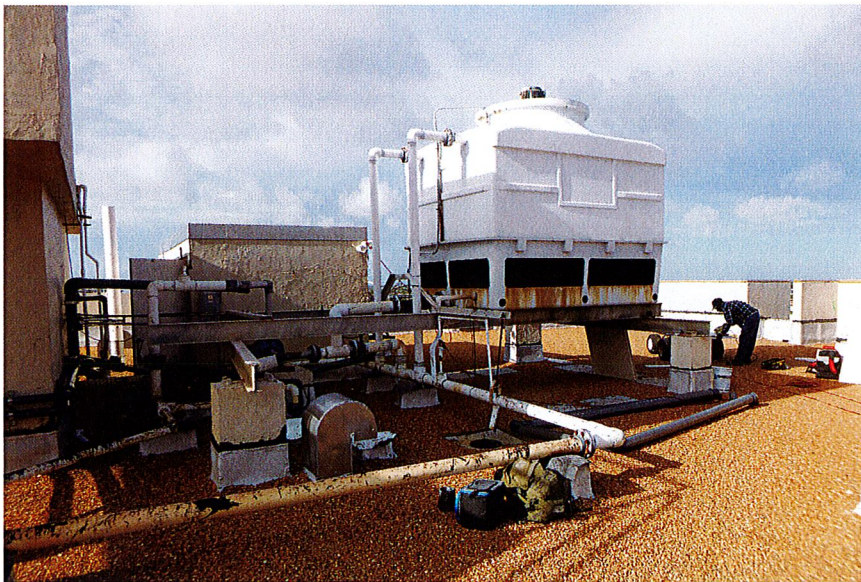
- iii. Cooling Tower Support Structures: There were isolated areas where the concrete pedestals supporting the steel beams showed some signs of cracking and deterioration. The galvanized steel I-beams showed signs of minor degradation and oxidation of the anchors. These identified conditions will need to be addressed and repaired.

Photo 19: Close-Up Photograph of the Cooling Tower Steel I-Beam Support and Concrete Pedestals.

- i. The reinforced concrete pedestals which supported the roof top steel beams have sustained minor oxidation and spalling. These conditions

need to be addressed and repaired to restore the long-term structural integrity of the support members.

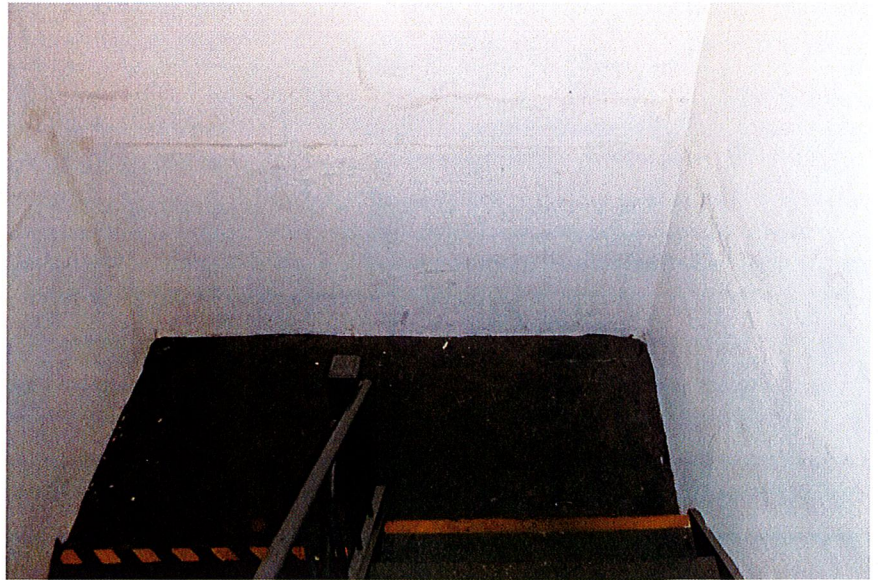
Photo 21: Photograph of the Staining
of the Ground Floor of the Stairwell
Walls as a Result of Moisture
Infiltration.

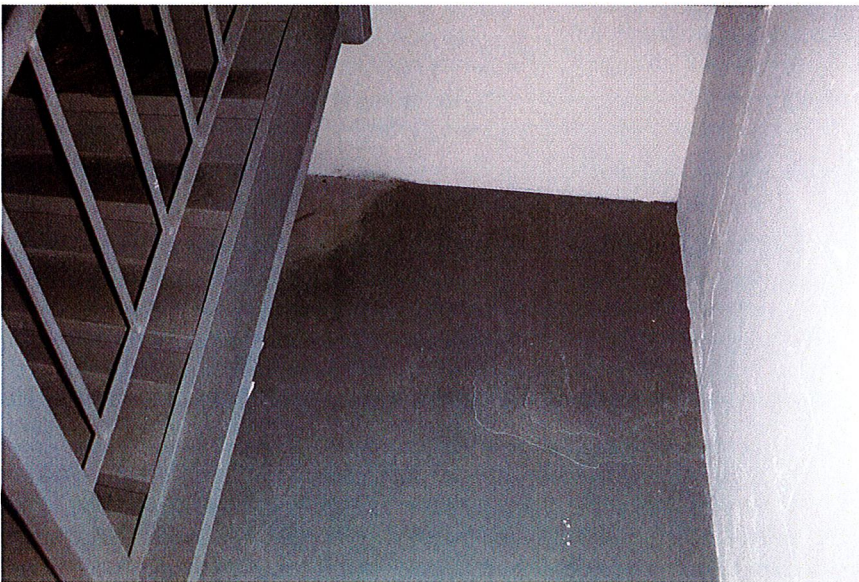
Photo 22: Photograph of the Staining
of an Upper Level of the Stairwell
Walls as a Result of Moisture
Infiltration.

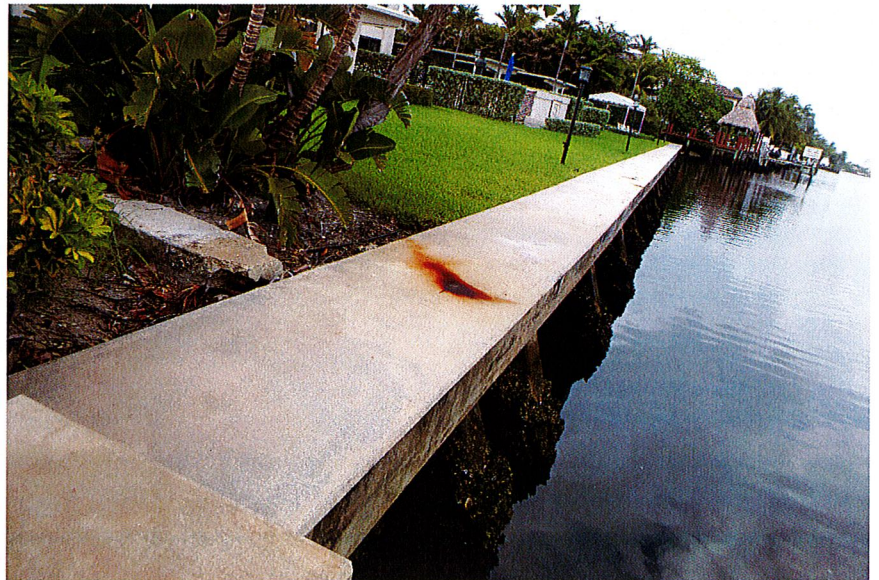
Photo 22: Photograph of the Seawall which Consist of Reinforced Concrete Panels, Prestressed King and Batter Piles, and a Reinforced Concrete Cap that Appears to have been Overlayed with a Secondary Pour.

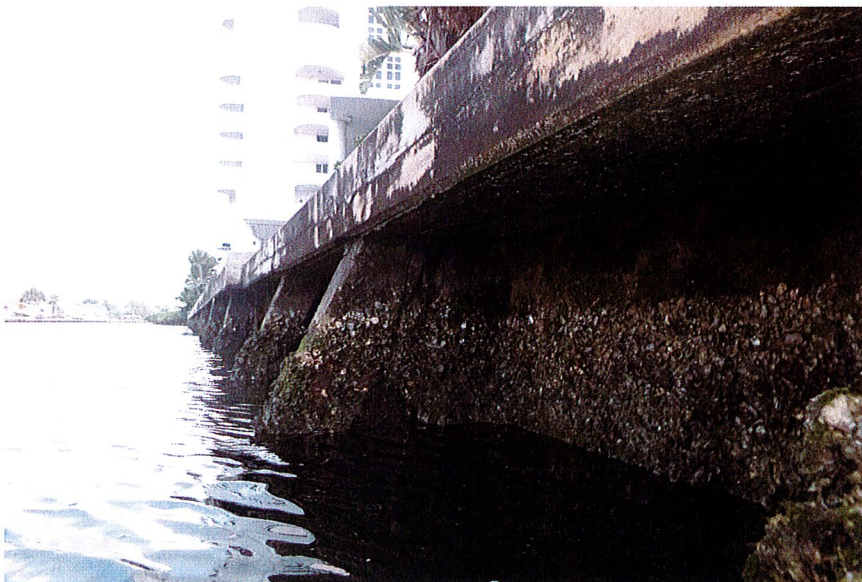
- g. The Ground Floor Glazing: The ground floor, hurricane rated storefront type glazing was inspected and there were no identified issues noted.
 - h. The Seawall: The seawall cap displayed signs of structural deterioration and oxidation, specifically the west facing façade of the cap was cracked and oxidation was bleeding out along portions of the cracks. The investigation from the water revealed widespread spalling and cracking along the top and bottom sides of the seawall cap. The prestressed batter and king piles have experienced widespread deterioration, resulting in cracked and/or displaced concrete along the upper portion of the batter and king piles (adjacent to the intersection with the seawall cap). The king piles also displayed signs of deterioration, with less displacement of concrete elements. Some seawall panels had begun to crack and the observed conditions indicate the migration of soil from behind the seawall, under the precast concrete panels. The termination of the seawall along the southernmost façade of the seawall and the adjacent property to the north will be critical when the remedial repairs are implemented.

Photo 23: Close-Up Photograph of the Seawall Cap and the Continuous Crack along the Apparent Concrete Overlay.

- v. The seawall showed significant spalling and deterioration of the reinforced and prestressed concrete elements, inclusive of the cap, batter and king piles, and concrete panels. The top of the seawall cap contains some minor cracking and oxidation staining. The seawall cap also contains significant horizontal cracking on the outside face, which appears to be a result of an overlay over the original seawall cap. The vertical structural support elements (king and batter piles) showed significant signs of deterioration, damaged, and displaced concrete along the piles intersection with the cap, severely impacting the structural capacity for these elements to resist lateral forces. The concrete panels showed some signs of cracking but the observed areas erosion from areas behind the seawall is indicative of significant soil migration from under the precast panels. The degradation of this important structural element is in need of repair and replacement to restore the structural integrity and long-term performance.

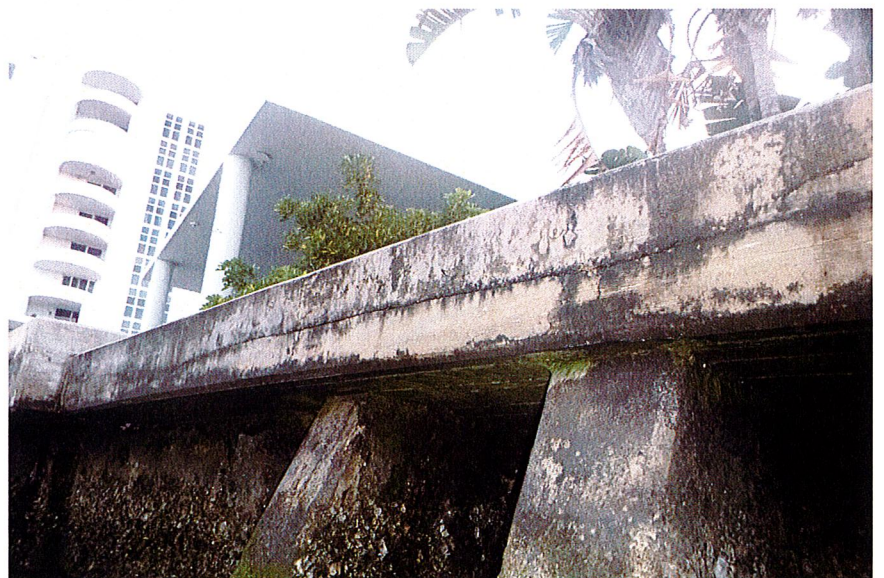
Photo 24: Photograph of the Cracking, Spalling, and Deterioation of the Reinforced and Prestressed Seawall Components.

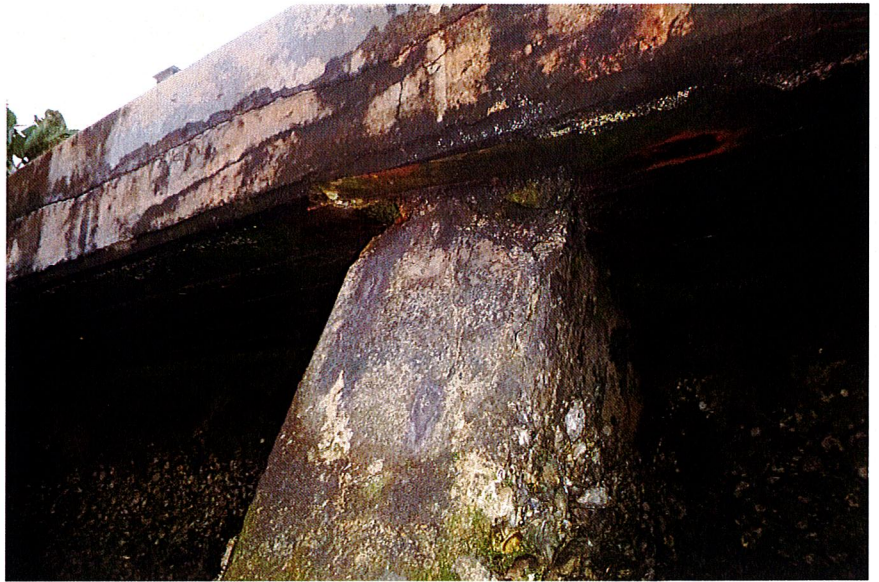
Photo 25: Close-Up Photograph of the Cracking, Spalling, and Deterioation of the Reinforced and Prestressed Seawall Components.

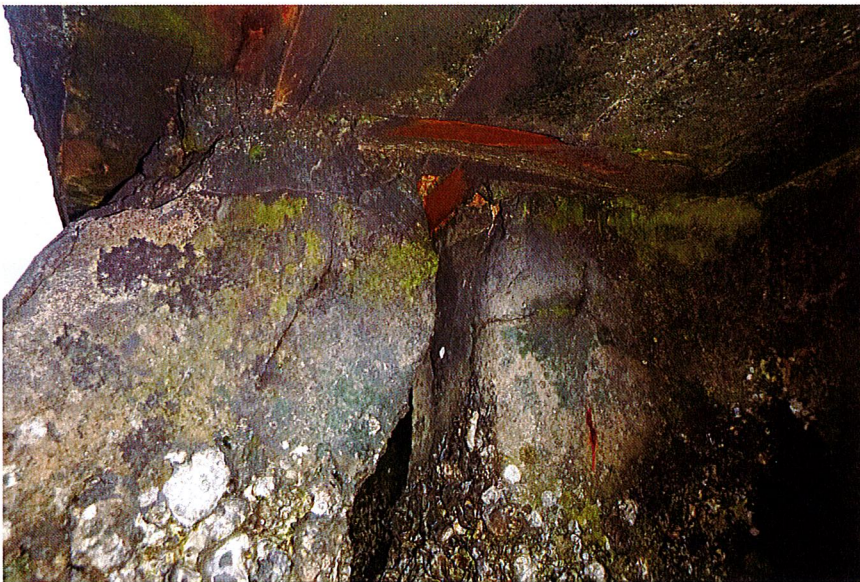
Photo 26: Photograph of a Complete Thru Crack of the Prestressed King Pile and Severe Oxidation of the Panel Tie-Back.

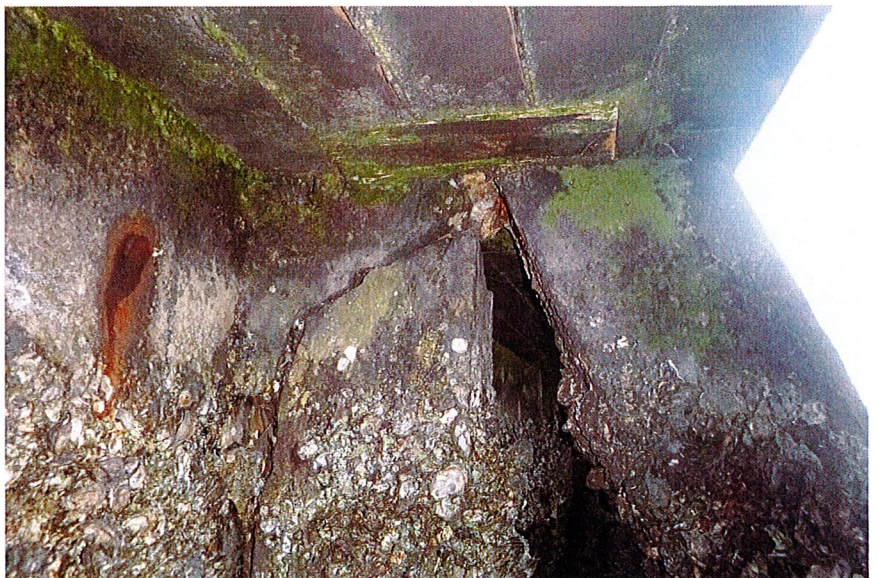
Photo 27: Photograph of a Complete Thru Crack of the Prestressed King Pile.

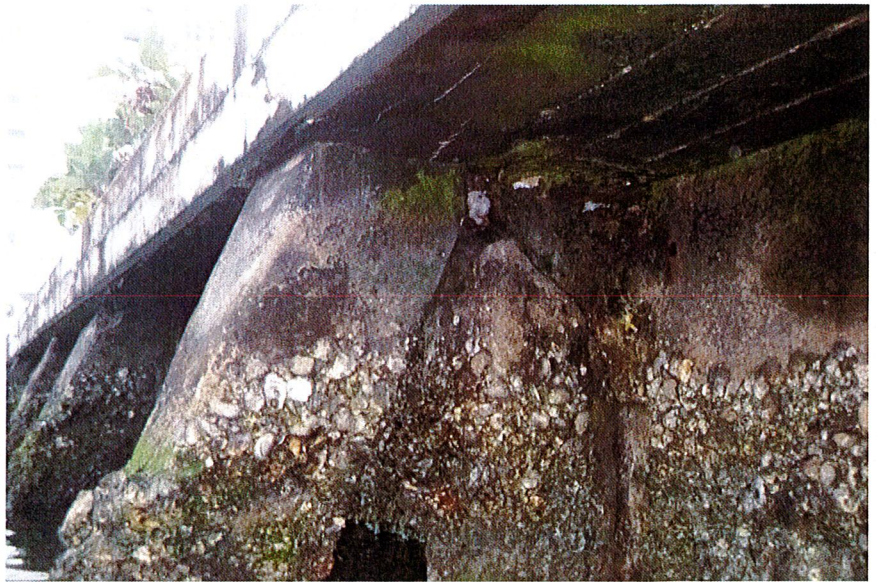
Photo 27: Photograph of a Significant Horizontal Crack in the Concrete Panel.

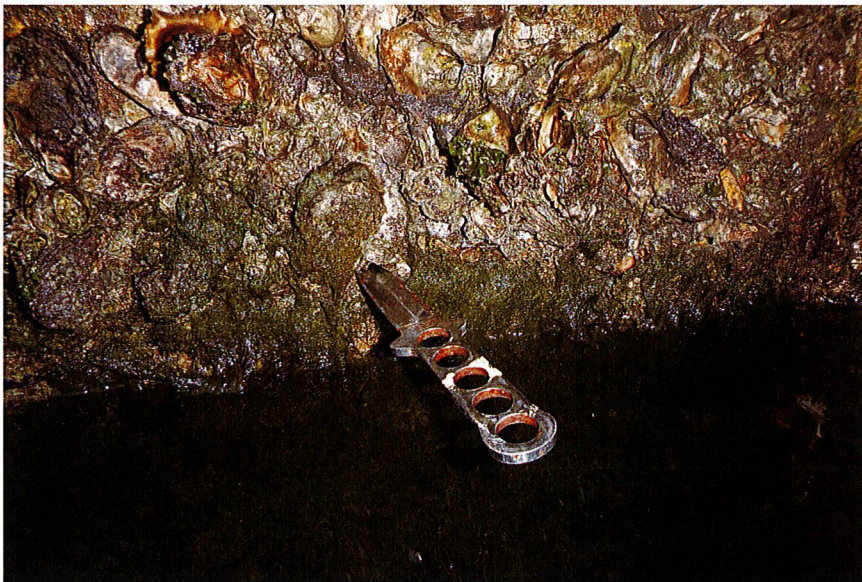
Photo 28: Photograph of the Cracking and Spalling of the Top of The Prestressed Concrete Batter Pile, Immediately underneath the Seawall Cap.

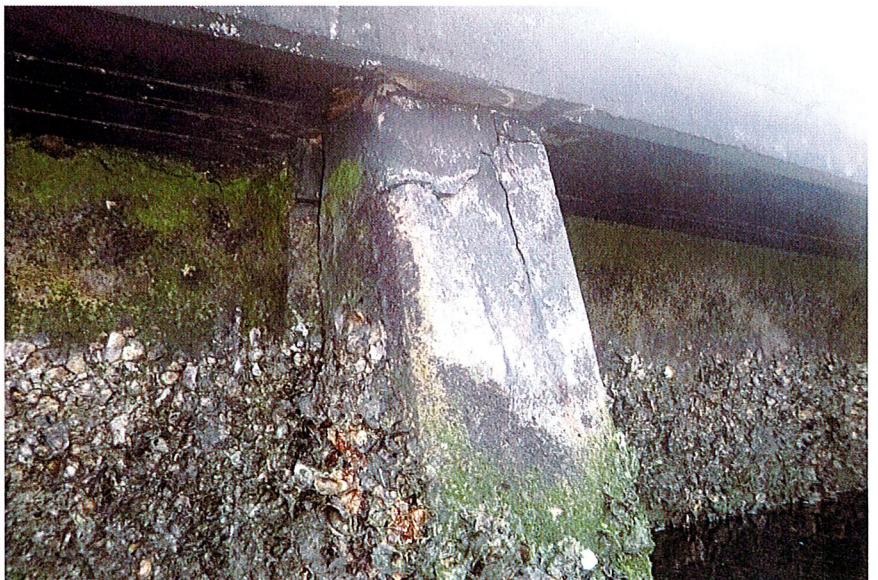
Photo 29: Close-Up Photograph of the Severe Cracking, Deterioration, and Deformation of the Prestressed Concrete Seawall Components.

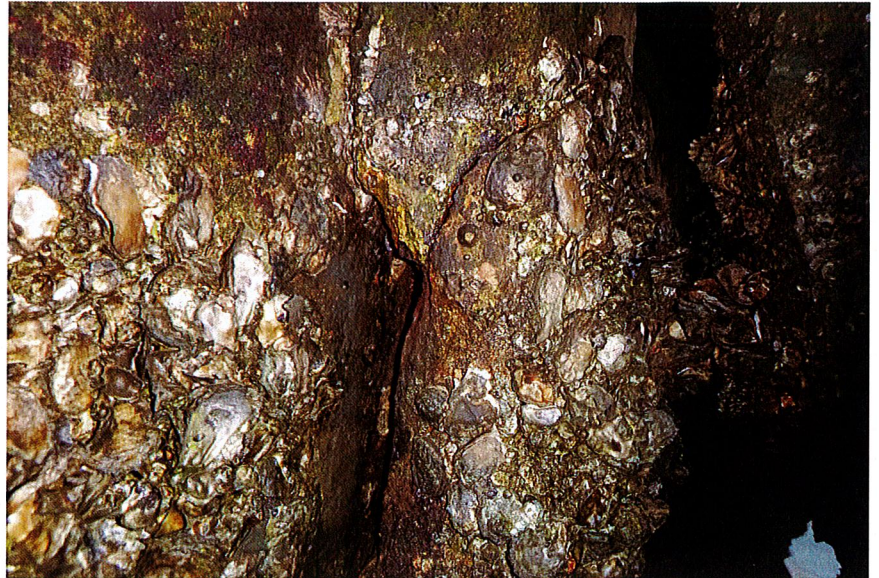
Photo 30: Close-Up Photograph of the Severe Cracking, Deterioration, and Deformation of the Prestressed Concrete Seawall Components.

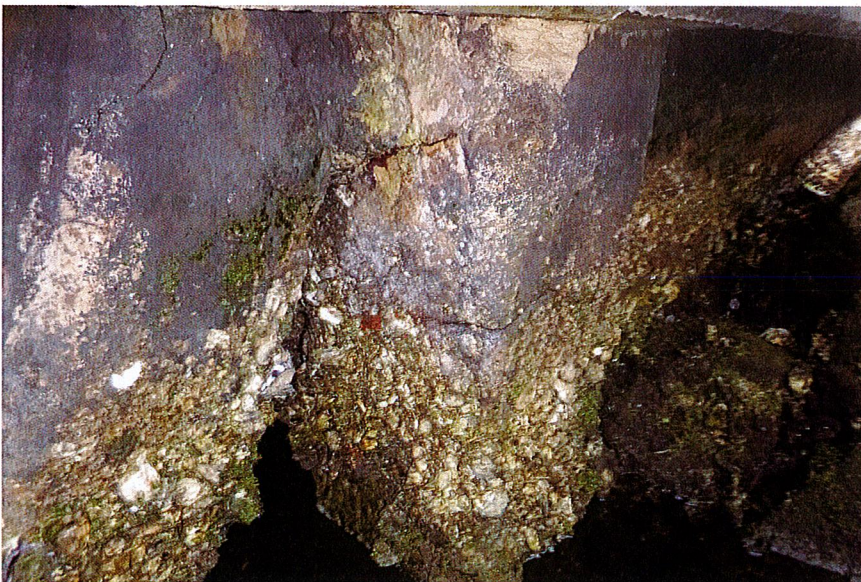
Photo 31: Photograph of the Cracking and Spalling of the Top of The Prestressed Concrete Batter Pile, Immediately underneath the Seawall Cap.

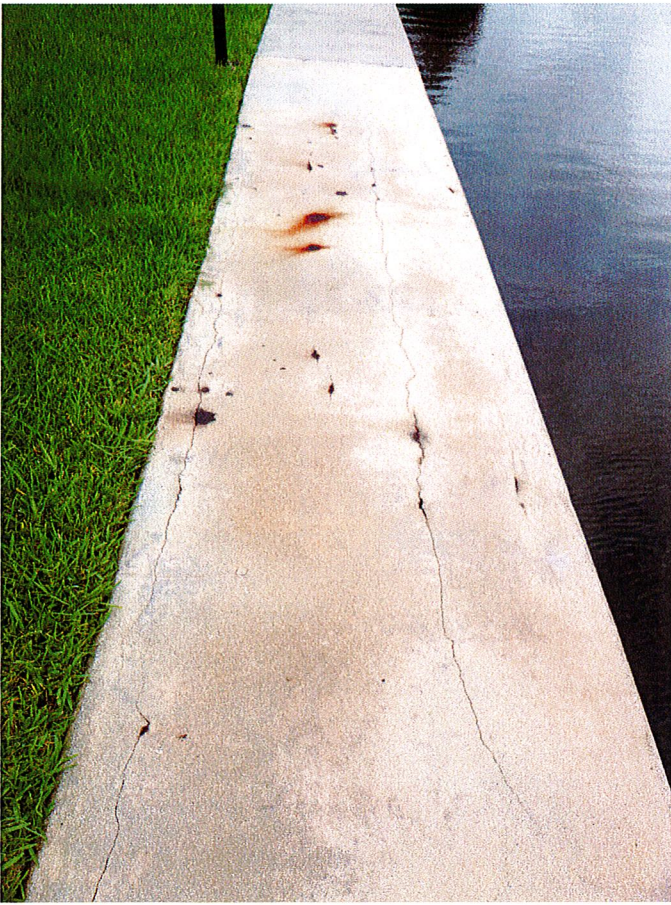
Photo 32: Deterioration of the Seawall Cap.

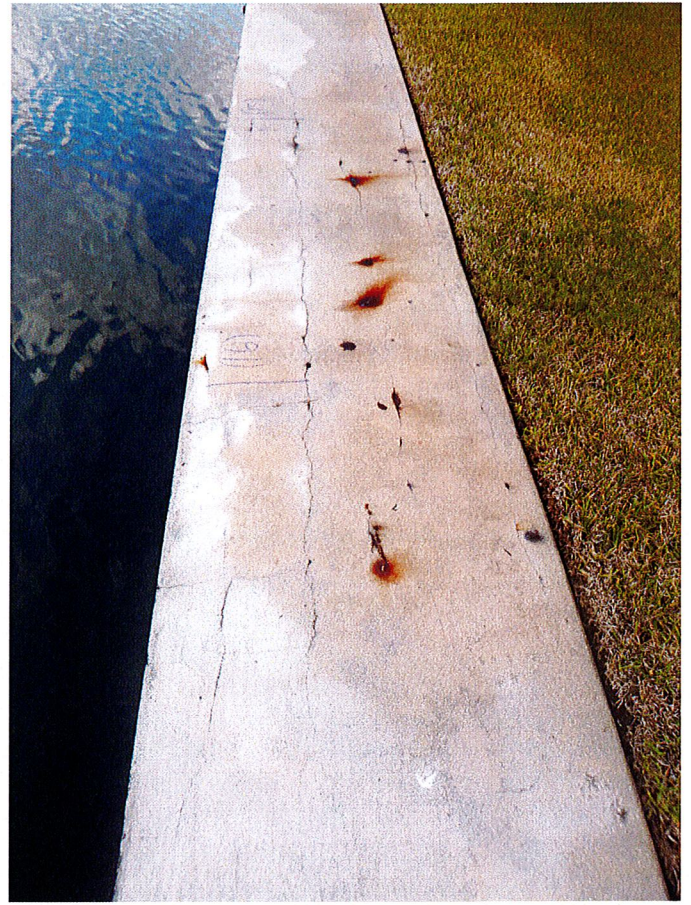
Photo 33: Deterioration of the Seawall Cap.

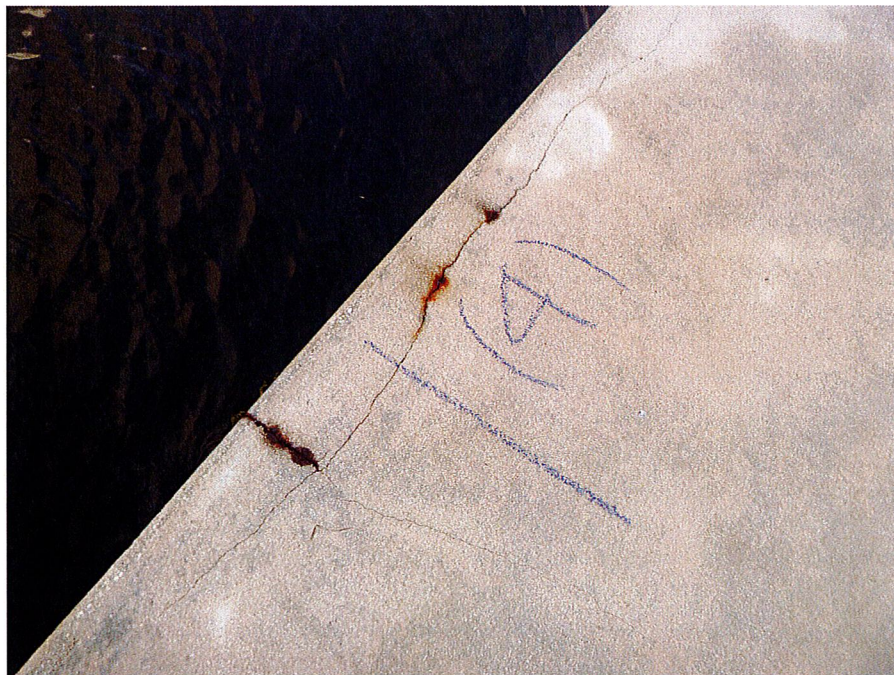
Photo 34: Deterioration of the Seawall Cap.
