# **PHASE 1 MILESTONE REPORT**

## **THE SENATE CONDOMINIUM**

**2500 PRESIDENTIAL Way**

**MILESTONE INSPECTION REPORT**

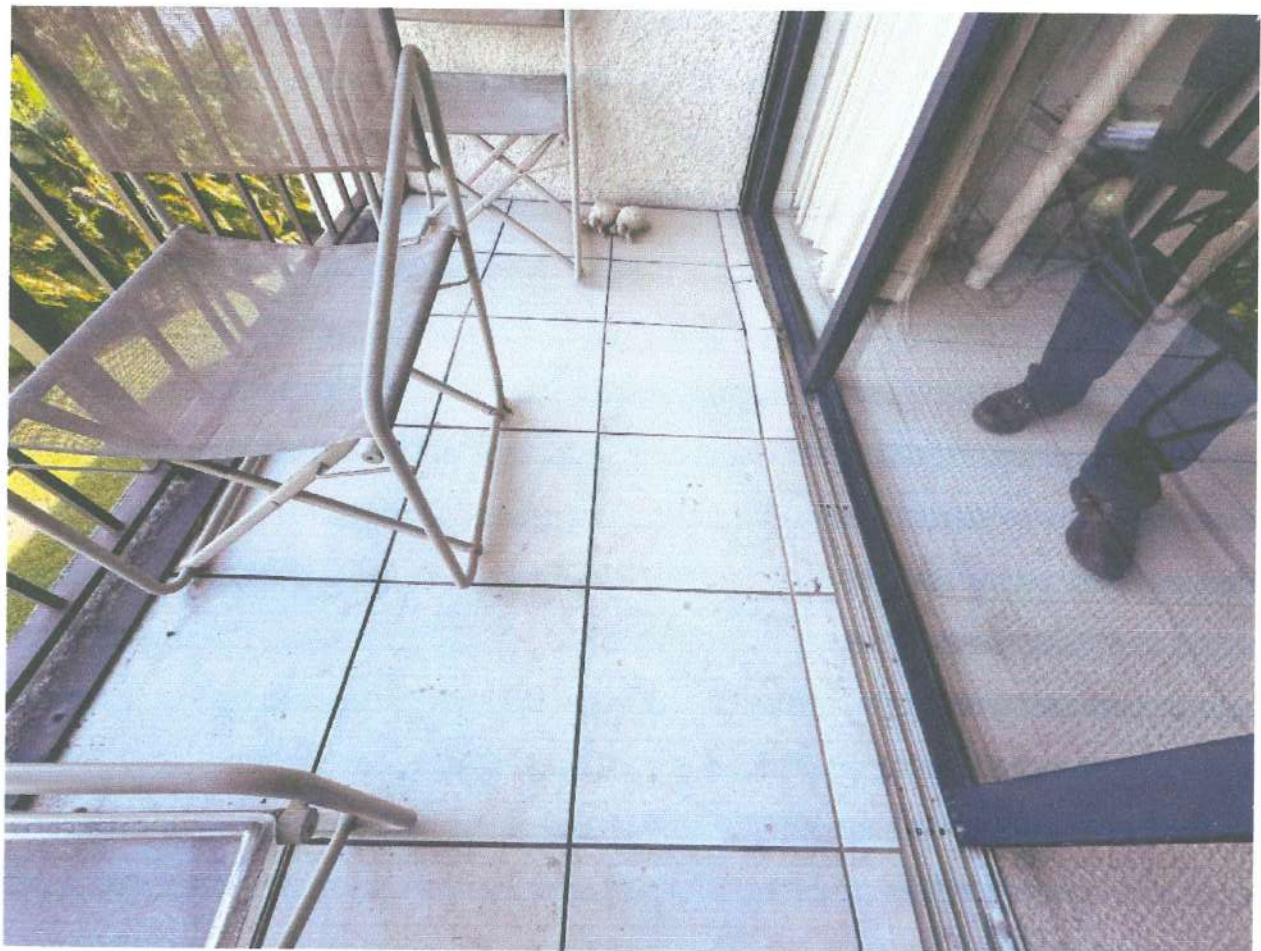
**Screen / Shutter Fasteners:** Typically, the screen enclosure and / or shutters along the edge cause edge problems eventually. The fasteners are typically Tapcons made from hardened steel that may or may not have had a sacrificial coating. Even though the fasteners may have been sealed with caulk when the screen was new, that sealant usually breaks down after 5 to 8 years. As the water starts to seep down past the fastener, the fastener will typically start to rust. As the rust happens, the fastener will first expand because rust is seven times the volume of steel. It will then lose volume and the salt water due to rain will seep down into the hole and out into the edge concrete, eventually causing the horizontal rebar along the edge to corrode. We did not observe much edge damage at this point, but you can expect to find some as time goes on.

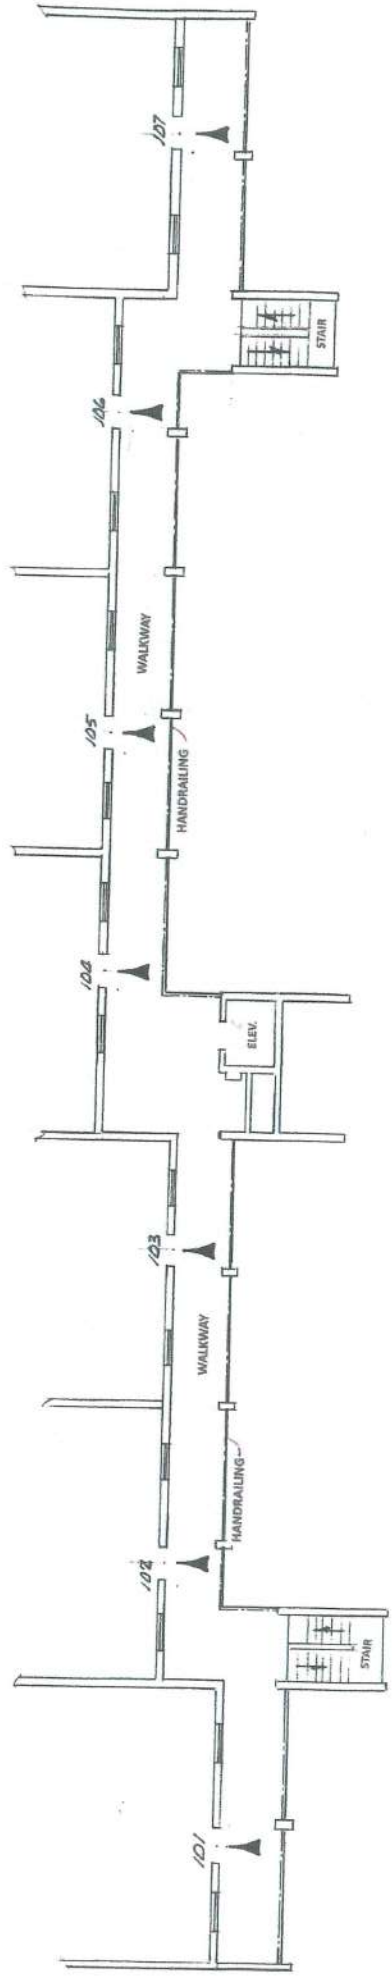
**BUILDING 2500: FIRST FLOOR WALKWAY**

*NOTHING NOTED*

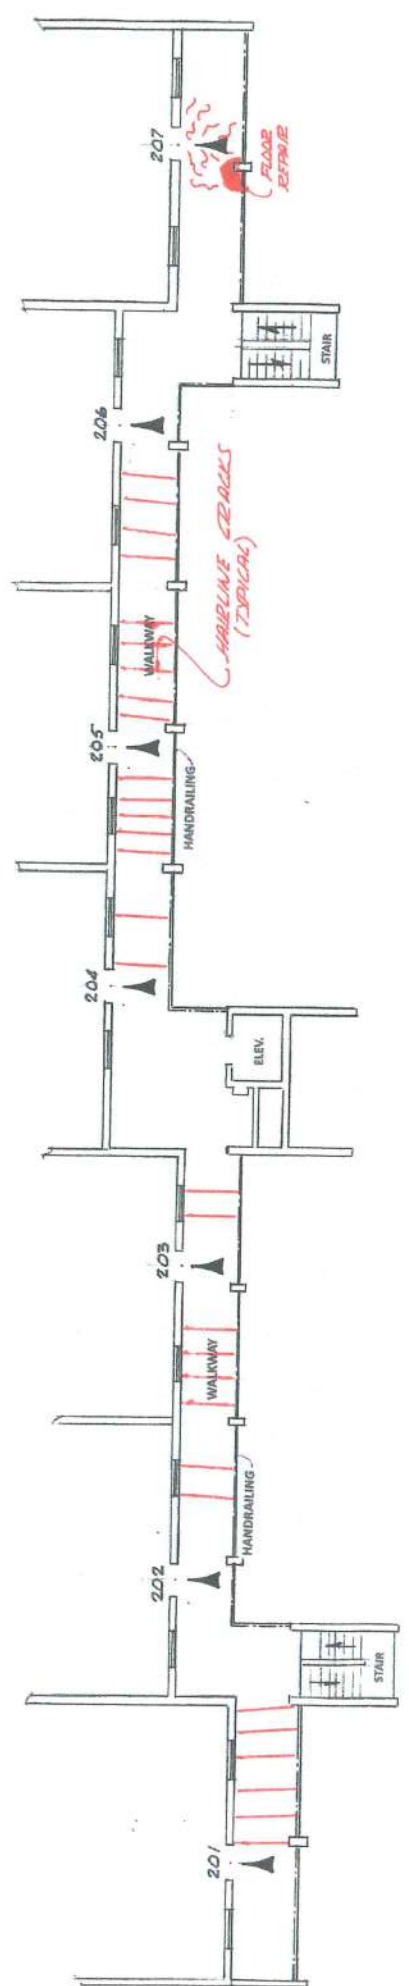
**BUILDING 2500: 2<sup>ND</sup> FLOOR WALKWAY**

*HAIRLINE CRACKS  
OVER ENTIRE WALKWAY*

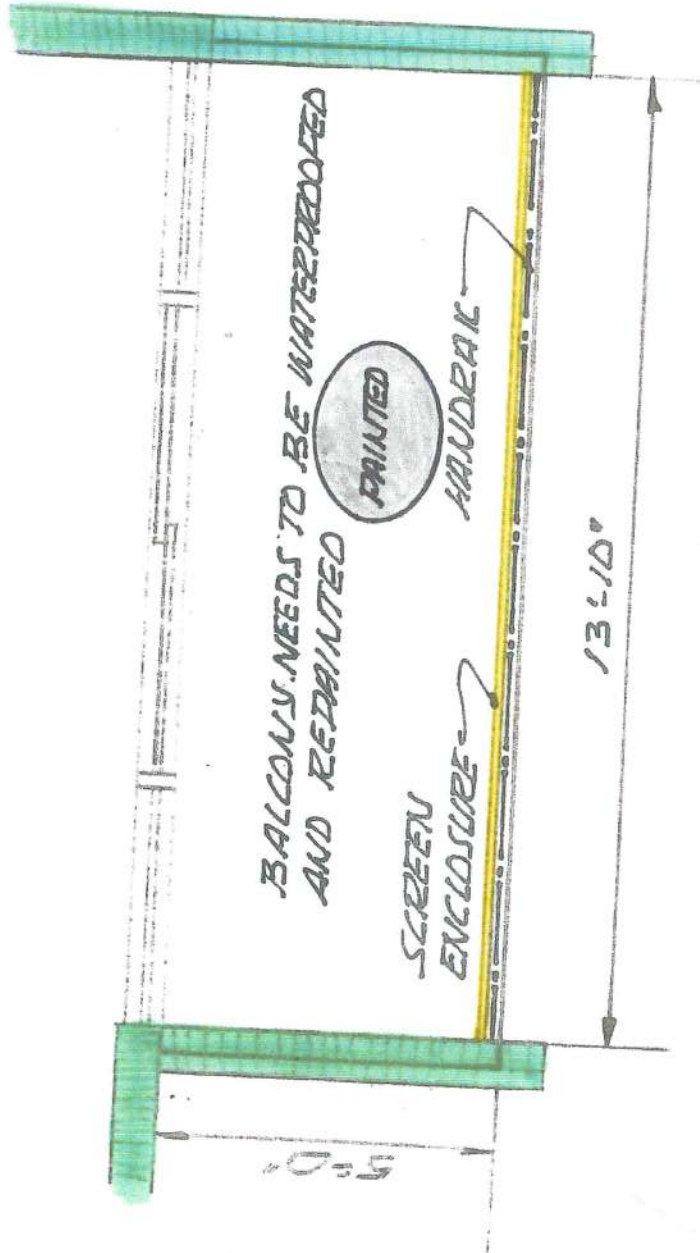
BALCONY NEEDS TO BE WATERPROOFED AND REDRAINED

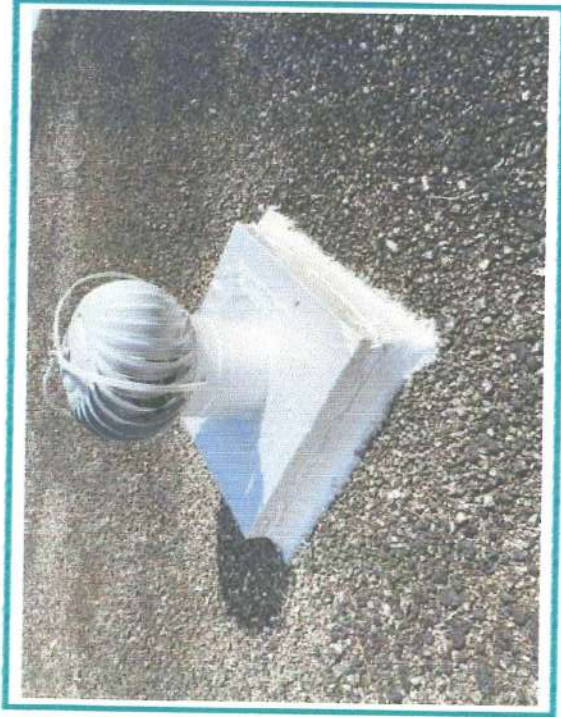
9. View of typical ventilator curb detail, well maintained

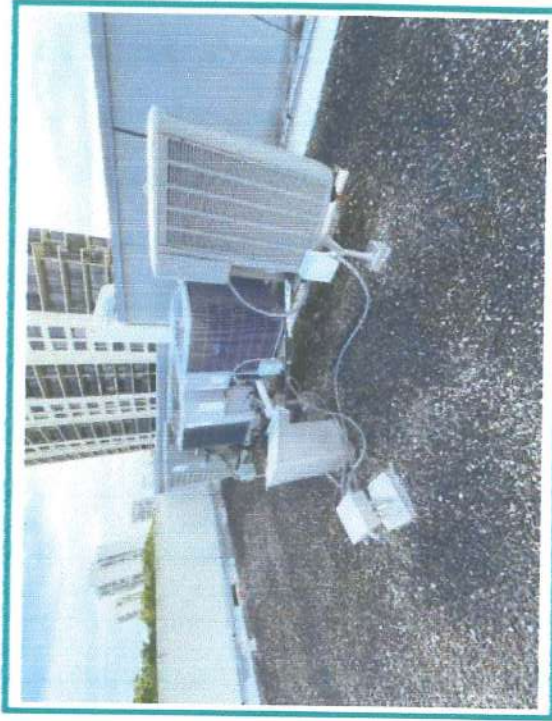
10. View of typical AC stand/chase detail, well maintained

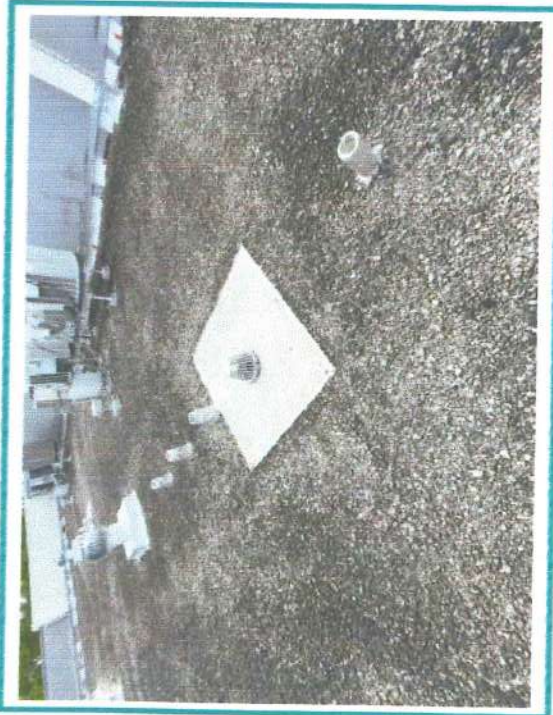
11. View of typical drain & soil stack detail, well maintained

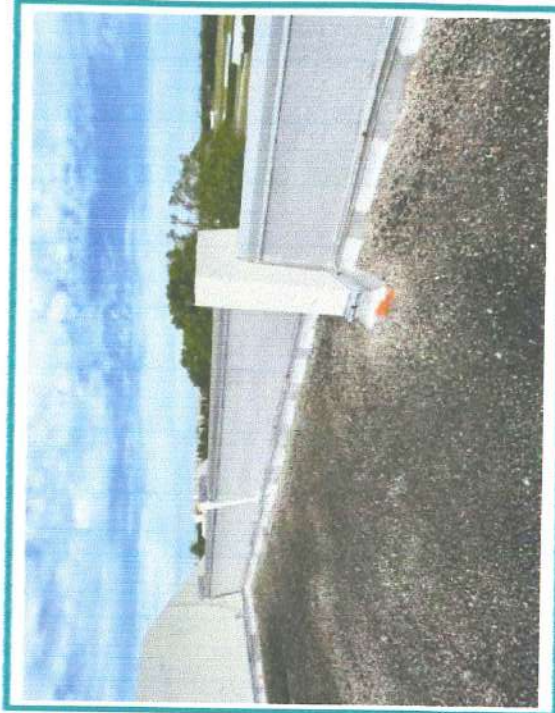
12. View of typical termination base detail, well maintained

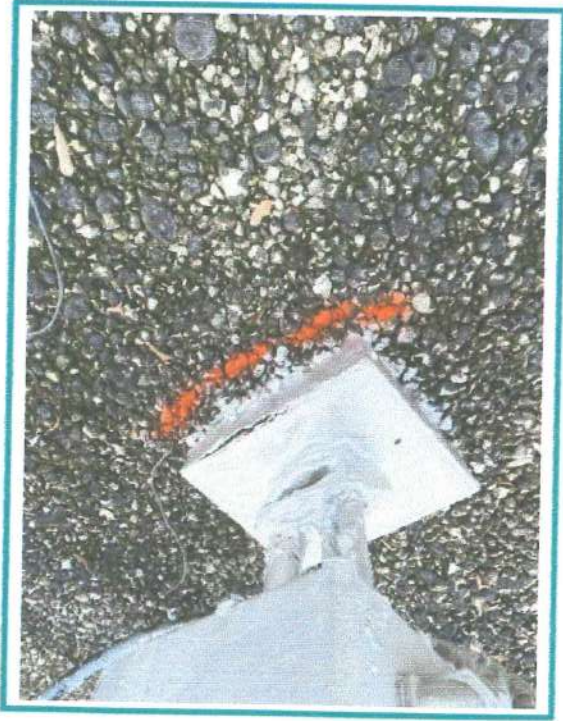
**13** Penetration pan slightly separated from fill, repair

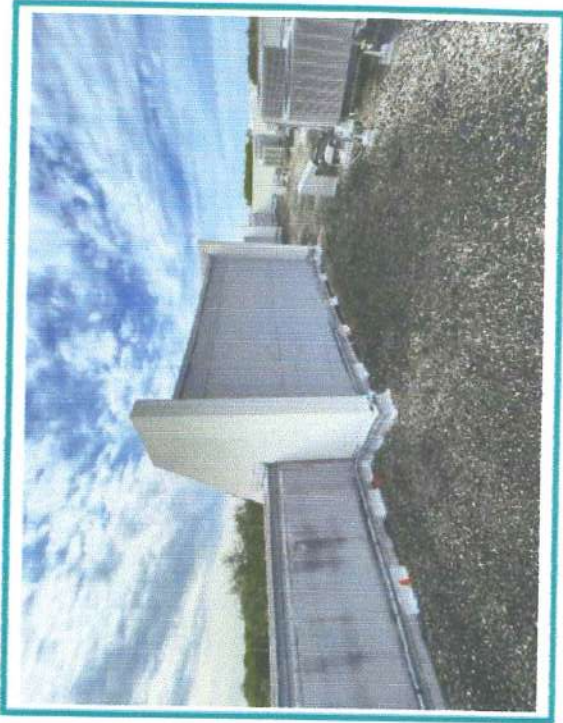
**14** View of typical parapet wall detail, well maintained
