# PHASE 1 MILESTONE REPORT

## SENATE CONDOMINIUM

**3050 PRESIDENTIAL WAY**

**MILESTONE INSPECTION REPORT**

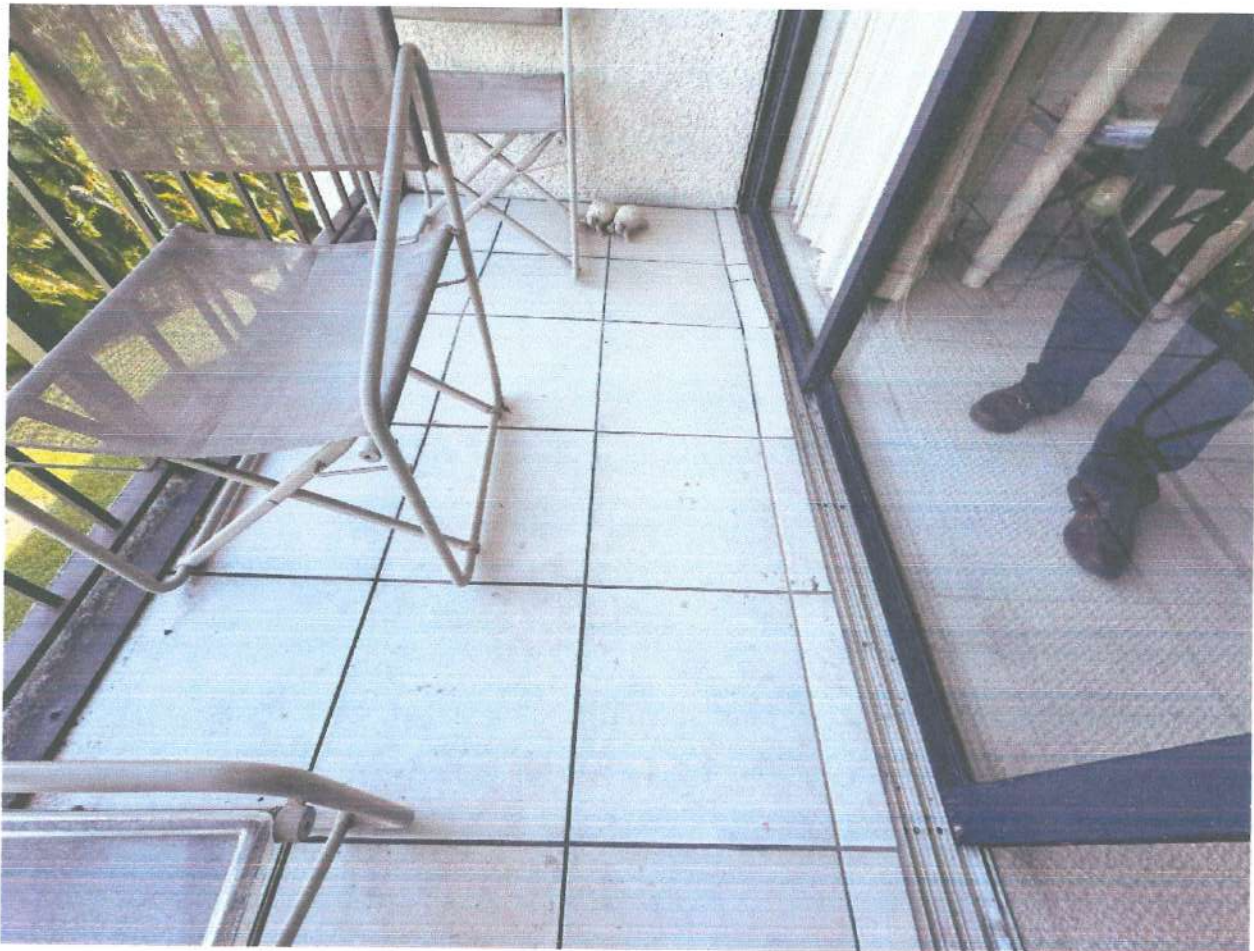
**Screen / Shutter Fasteners:** Typically, the screen enclosure and / or shutters along the edge cause edge problems eventually. The fasteners are typically Tapcons made from hardened steel that may or may not have had a sacrificial coating. Even though the fasteners may have been sealed with caulk when the screen was new, that sealant usually breaks down after 5 to 8 years. As the water starts to seep down past the fastener, the fastener will typically start to rust. As the rust happens, the fastener will first expand because rust is seven times the volume of steel. It will then lose volume and the salt water due to rain will seep down into the hole and out into the edge concrete, eventually causing the horizontal rebar along the edge to corrode. We did not observe much edge damage at this point, but you can expect to find some as time goes on.

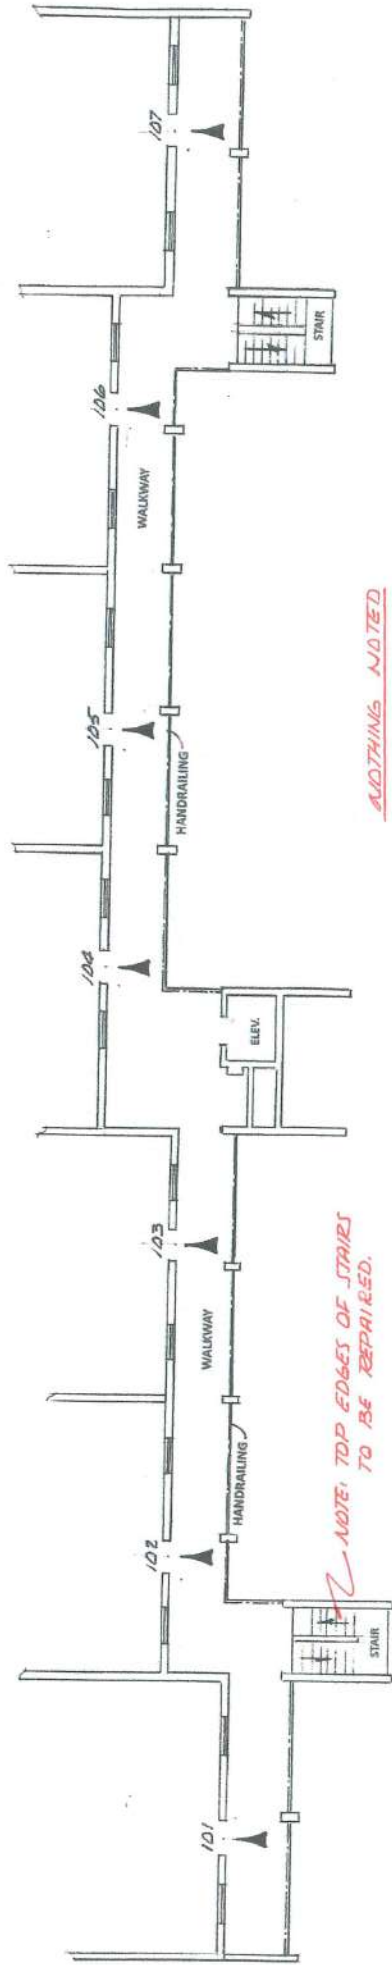
*NOTE: TOP EDGES OF STAIRS TO BE REPAIRED.*

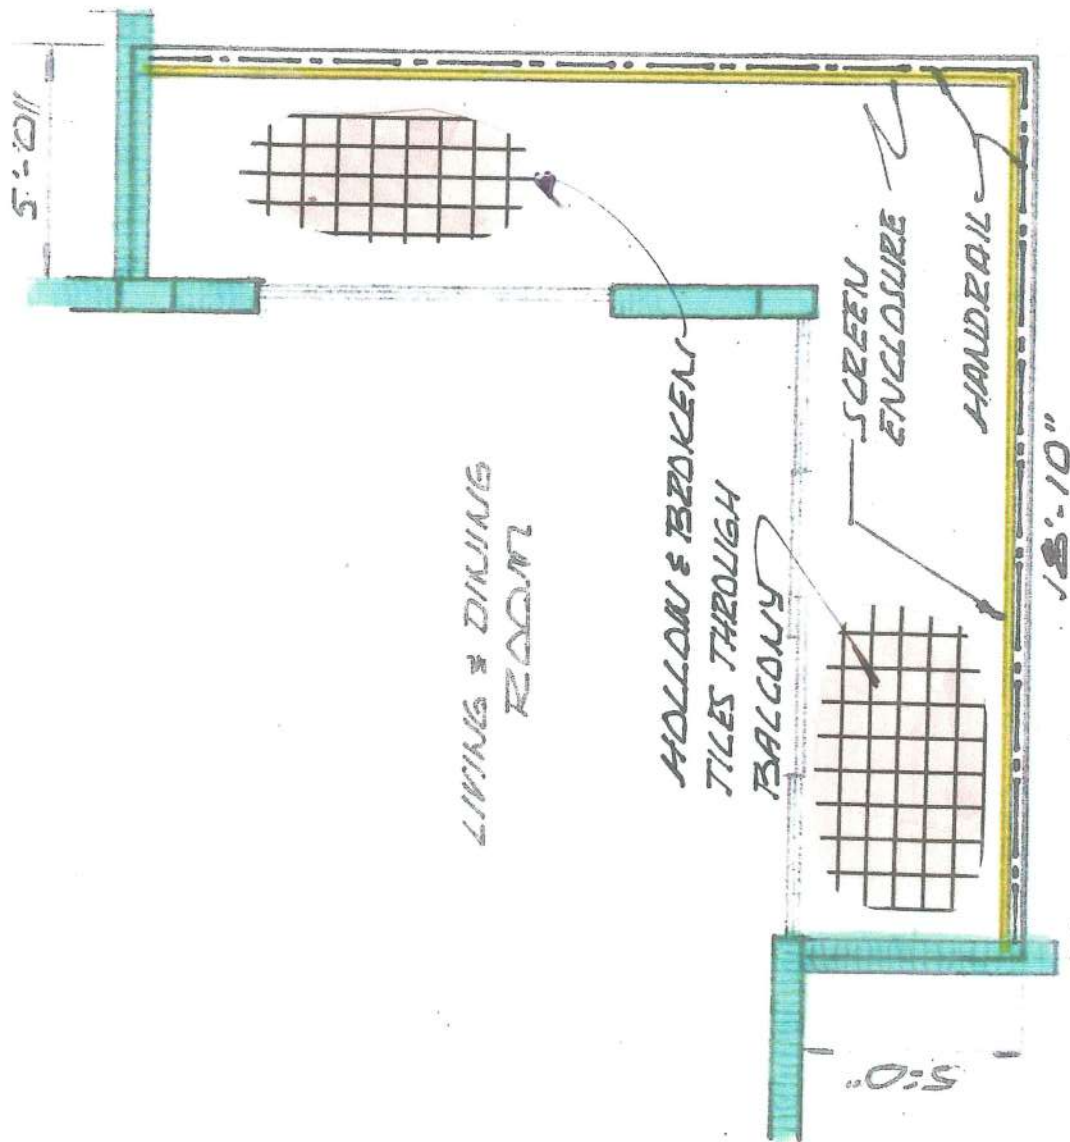
**BUILDING NUMBER 3050**

Unit 201: Hollow and broken tiles. All tiles need to be removed (Ref Note 'A')

**Note 'A':** In areas where all or most of the tiles are hollow sounded, we recommend that all the tiles be removed, the balcony be ground down to bare concrete, inspected, repaired as needed, and waterproofed.

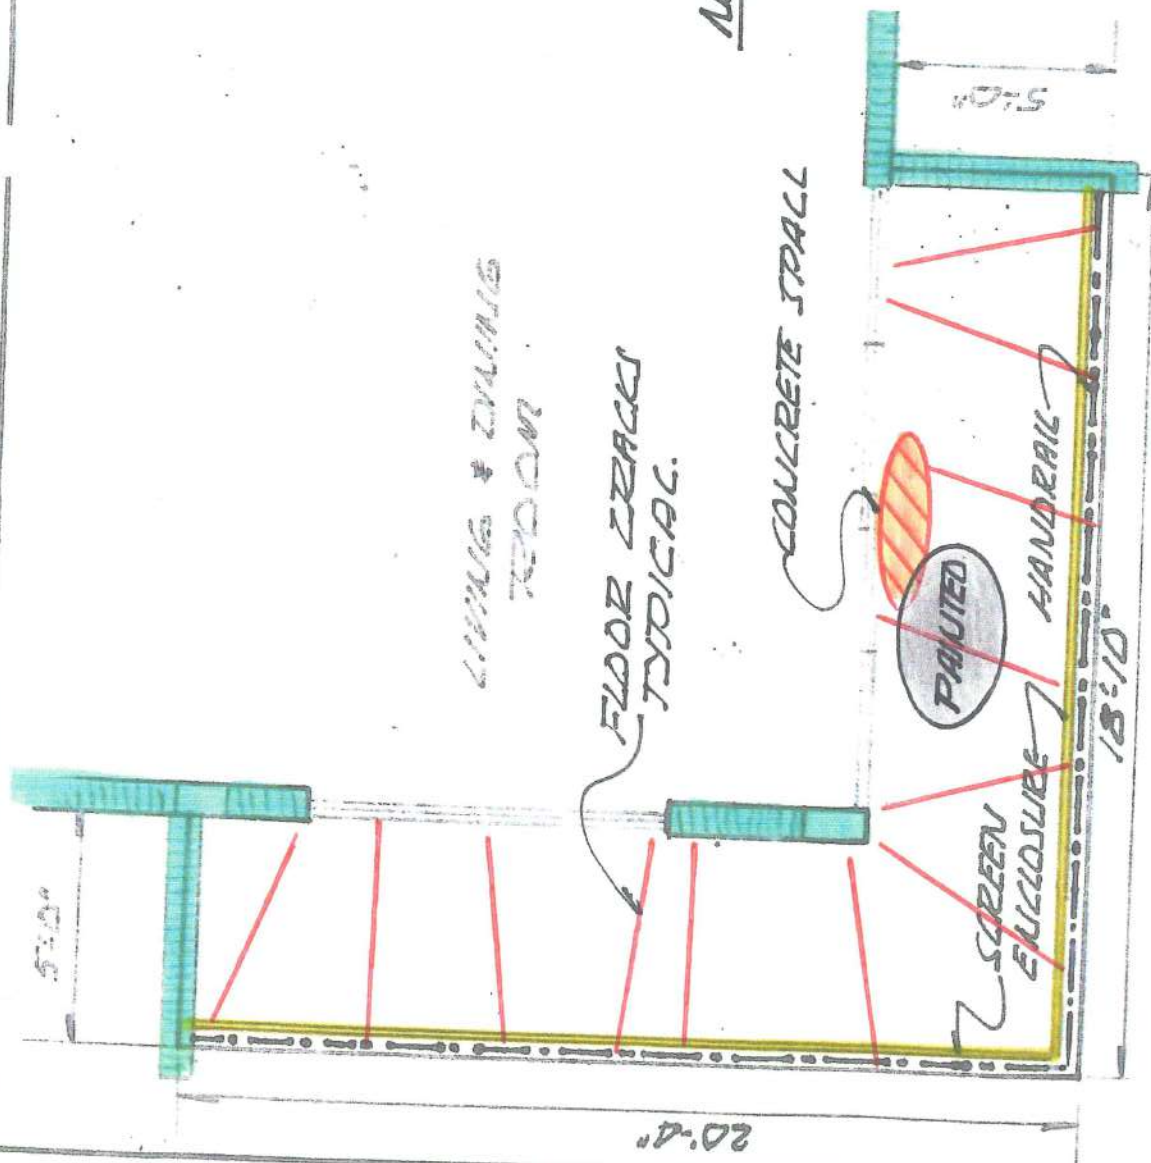
NOTE: CRACKS THROUGH OUT  
BALCONY. DECK TO BE  
CLEANED DOWN TO BARE  
CONCRETE, REINSPECTED,  
REPAIRED & WATERPROOFED.

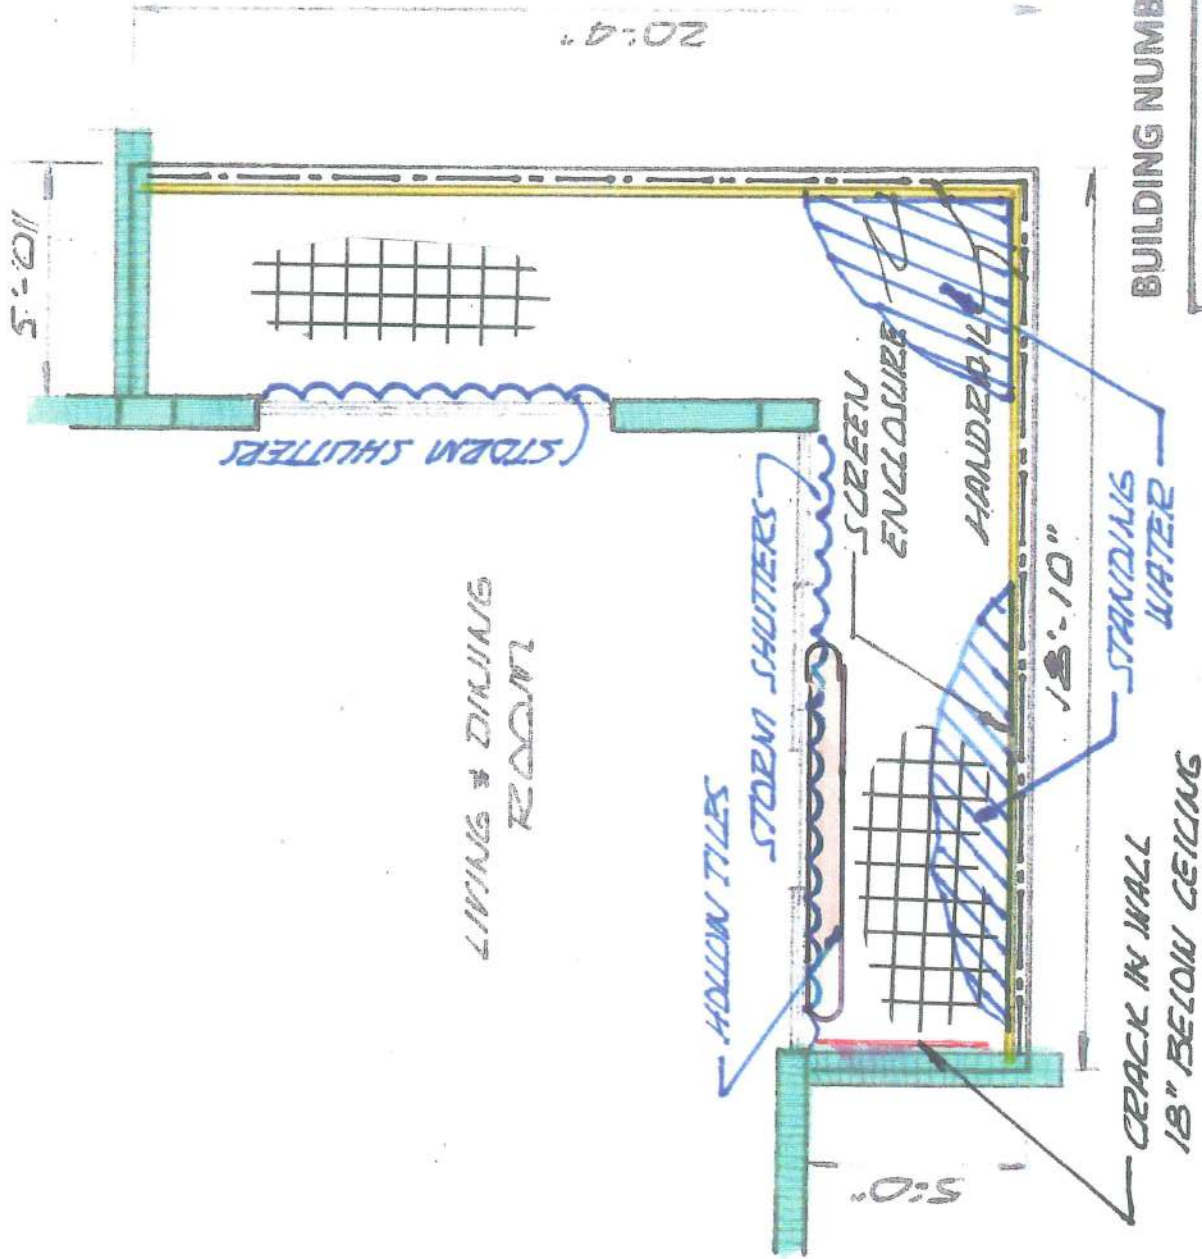
**NOTE:** STANDING WATER  
AT SCREEN TRACKS  
DUE TO NO WEED  
HOLES IN TRACKS.

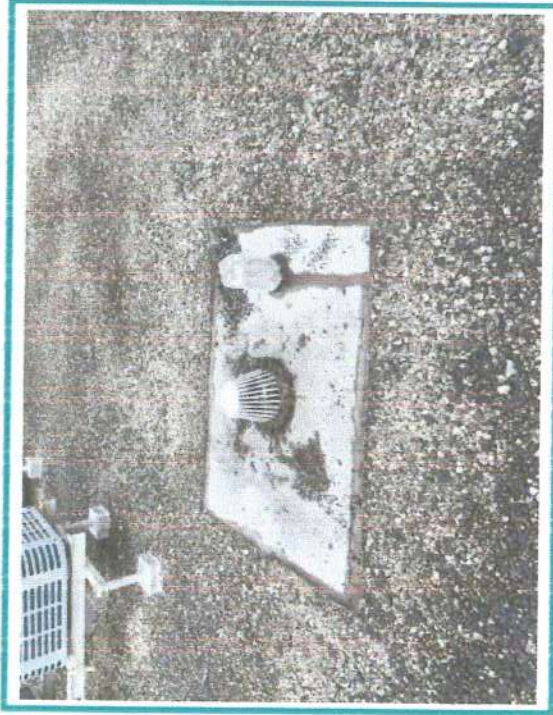
9. View of typical interior drain detail, boarder needs coating

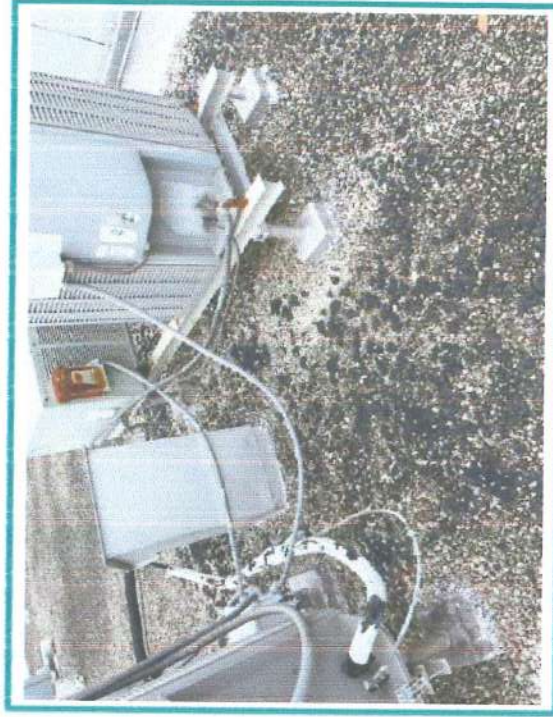
10. View of typical AC stand/chase details, well maintained

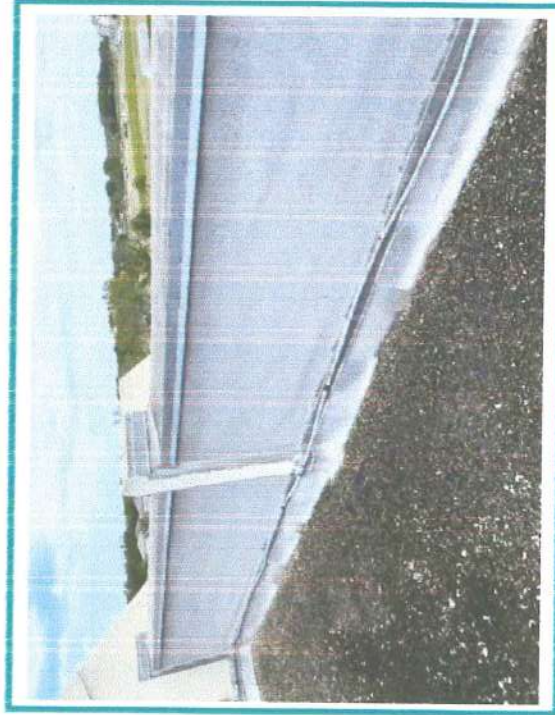
11. View of typical flashed parapet wall detail, well maintained

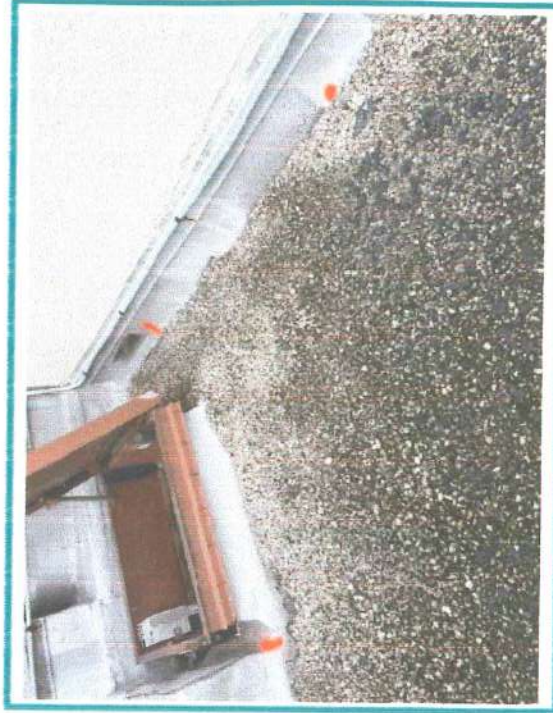
12. Small isolated area of subsurface water adjacent to hatch

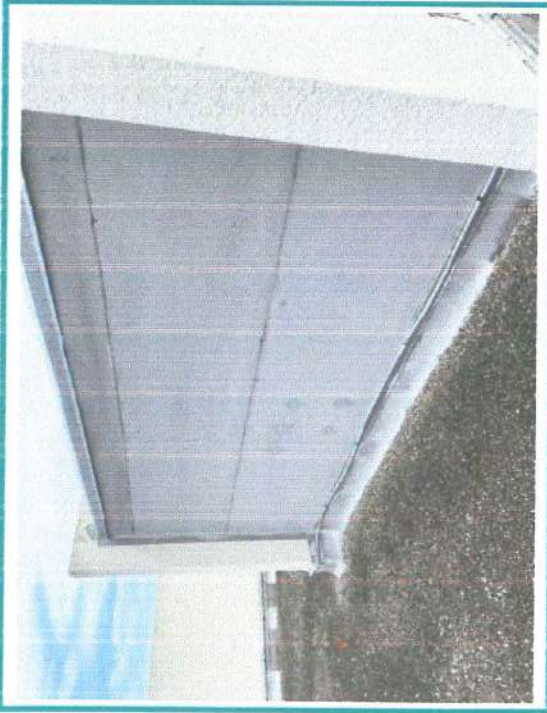
**13** View of typical flashed parapet wall detail, well maintained

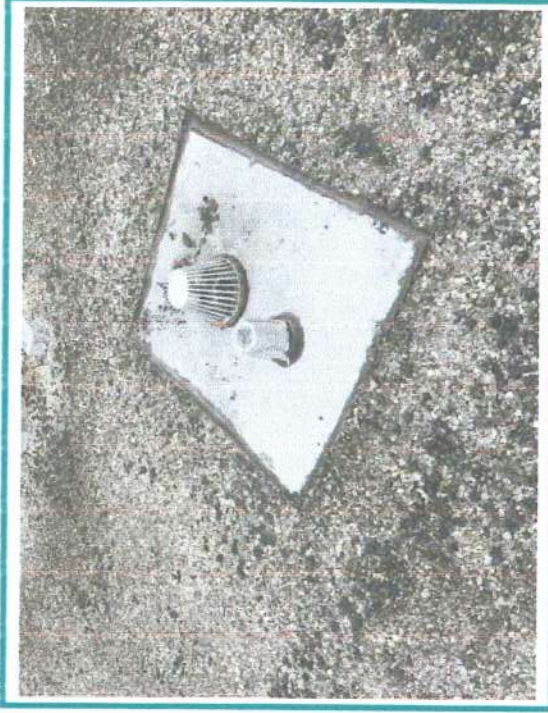
**14** View of typical interior drain detail, boarder needs coating
