Subject: Reserve Study for Villagio Del Mar HOA

**EXECUTIVE SUMMARY April 2023 Villagio Del Mar Reserve Study**

**Villagio Del Mar HOA, Inc.**  
***Hypoluxo, FL***

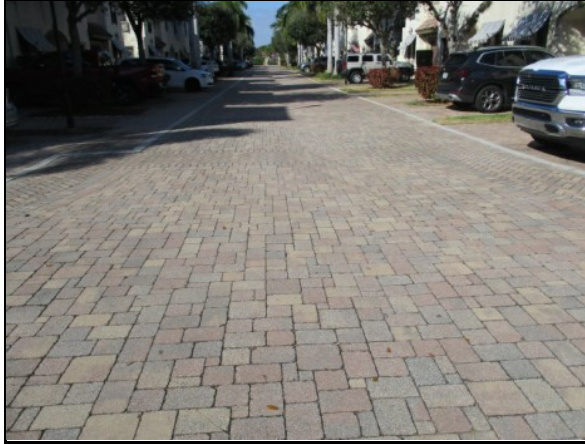
Useful Life:  
30 years

Remaining Life:  
12 years

Best Case: \$ 115,000

Worst Case: \$ 130,000

Lower estimate to replace

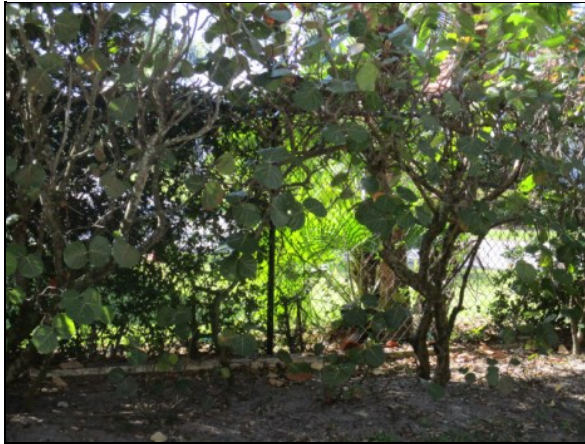
Useful Life:  
30 years

Remaining Life:  
12 years

Best Case: \$ 34,100

Worst Case: \$ 41,700

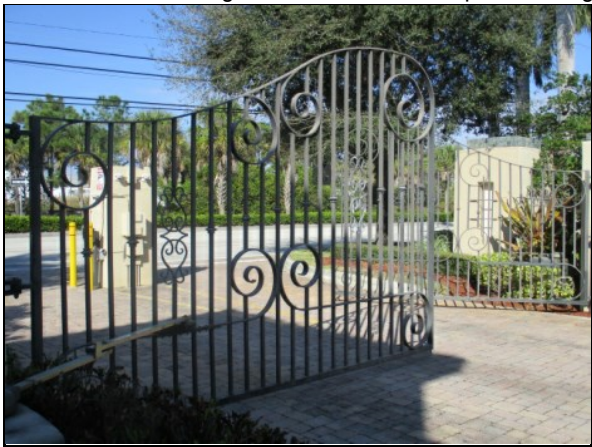
Useful Life:  
30 years

Remaining Life:  
12 years

Best Case: \$ 22,700

Worst Case: \$ 27,700

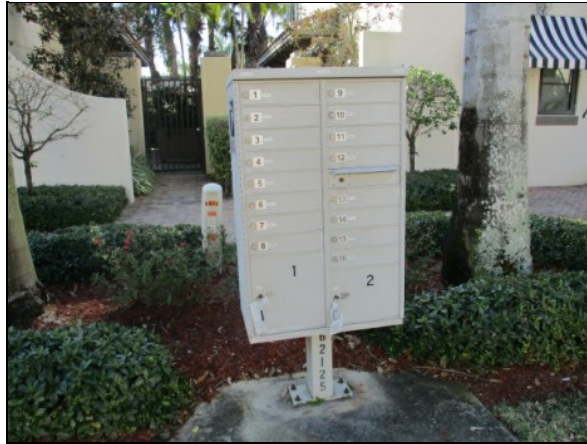
Useful Life:  
15 years

Remaining Life:  
0 years

Best Case: \$ 9,500

Worst Case: \$ 11,500

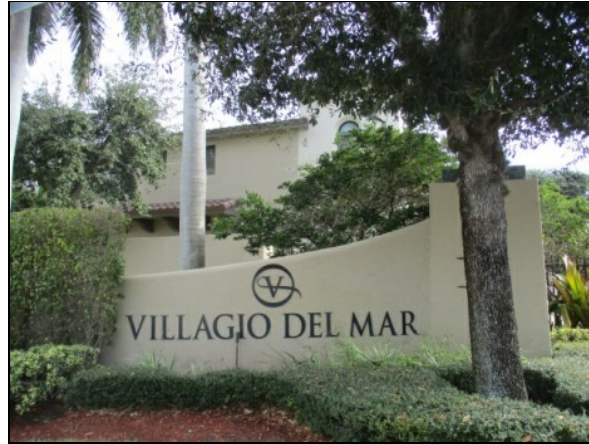
Useful Life:  
20 years

Remaining Life:  
5 years

Best Case: \$ 6,300

Worst Case: \$ 7,700

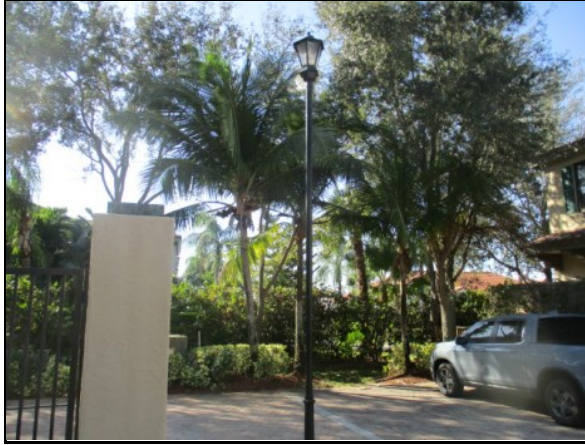
Useful Life:  
20 years

Remaining Life:  
2 years

Best Case: \$ 27,000

Worst Case: \$ 33,000

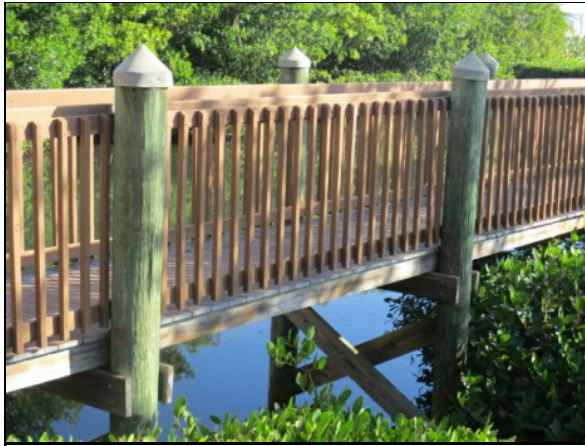
Useful Life:  
30 years

Remaining Life:  
12 years

Best Case: \$ 70,000

Worst Case: \$ 90,000

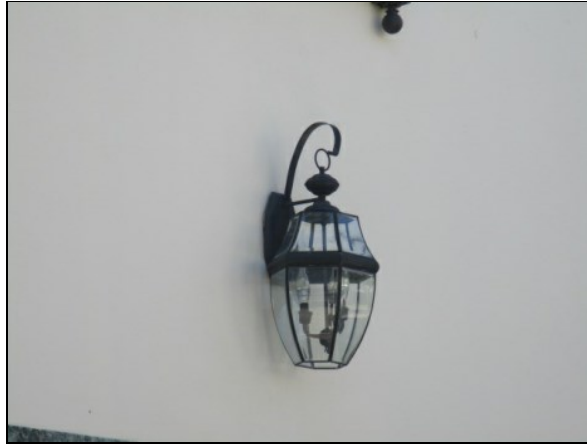
Useful Life:  
15 years

Remaining Life:  
10 years

Best Case: \$ 6,000

Worst Case: \$ 8,000

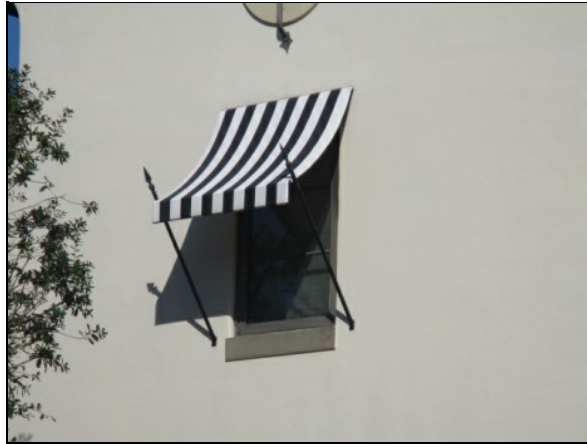
Useful Life:  
10 years

Remaining Life:  
5 years

Best Case: \$ 7,200

Worst Case: \$ 8,800

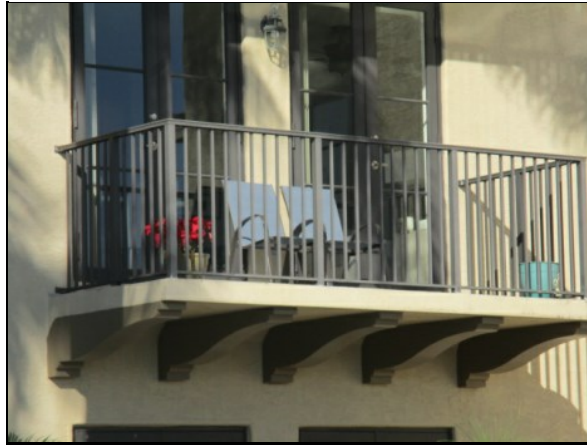
Useful Life:  
25 years

Remaining Life:  
7 years

Best Case: \$ 18,000

Worst Case: \$ 24,000

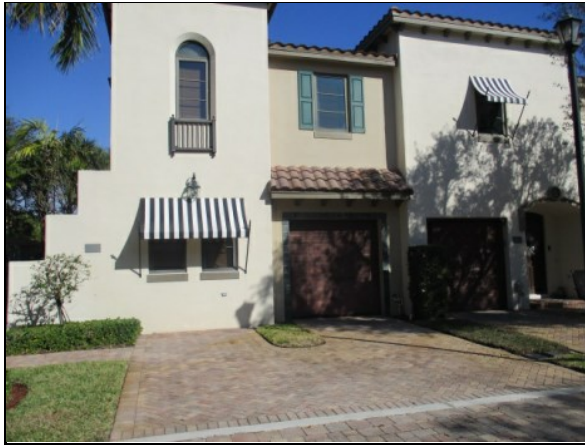
Useful Life:  
7 years

Remaining Life:  
6 years

Best Case: \$ 8,000

Worst Case: \$ 12,000

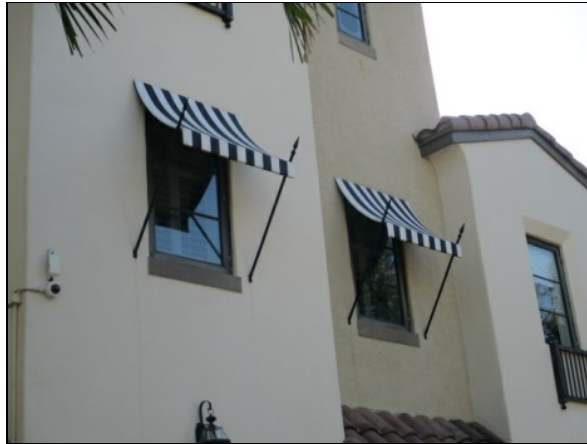
Remaining Life:

6 years

Best Case: \$ 135,000

Worst Case: \$ 165,000

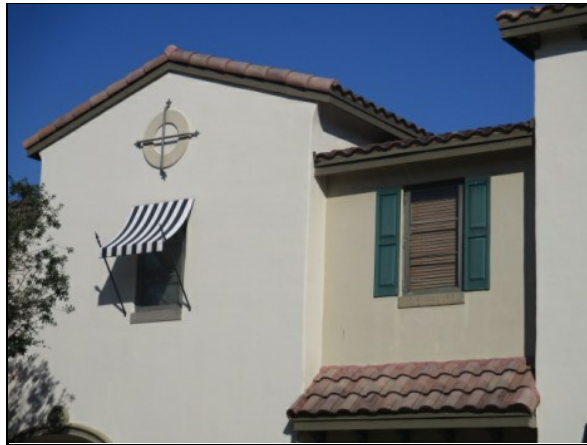
Useful Life:  
25 years

Remaining Life:  
7 years

Best Case: \$ 750,900

Worst Case: \$ 917,800

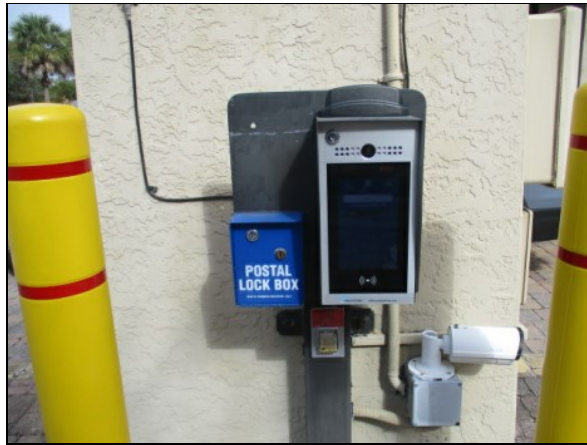
Useful Life:  
15 years

Remaining Life:  
12 years

Best Case: \$ 4,500

Worst Case: \$ 5,500

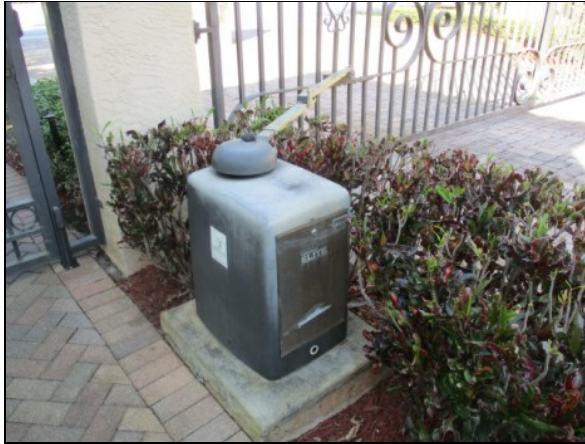
Useful Life:  
15 years

Remaining Life:  
0 years

Best Case: \$ 9,000

Worst Case: \$ 11,000

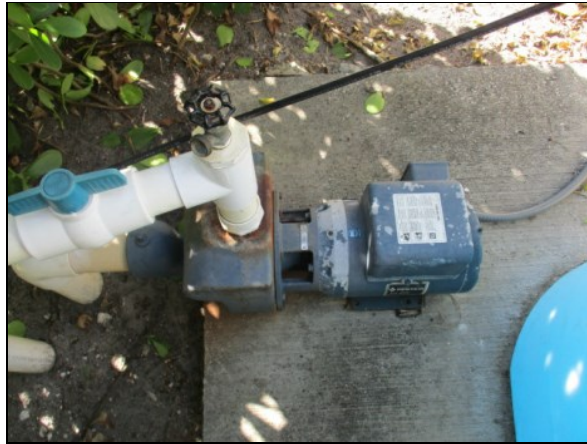
Useful Life:  
10 years

Remaining Life:  
3 years

Best Case: \$ 5,400

Worst Case: \$ 6,600

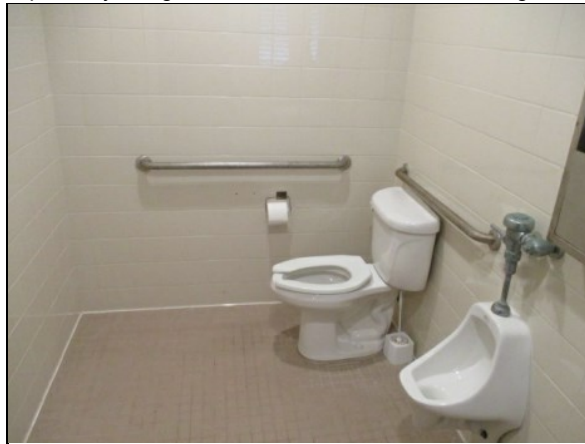
Remaining Life:

2 years

Best Case: \$ 13,000

Worst Case: \$ 15,800

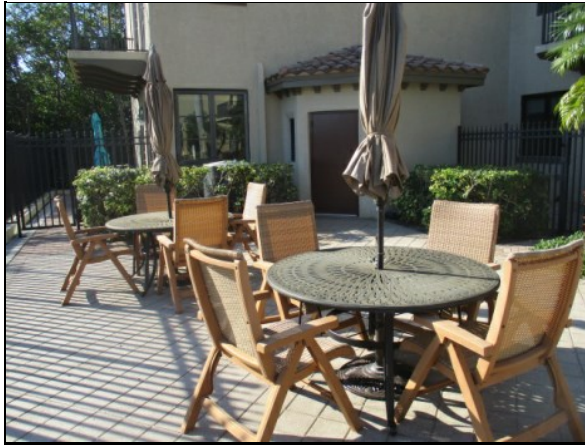
Useful Life:  
8 years

Remaining Life:  
4 years

Best Case: \$ 7,900

Worst Case: \$ 9,700

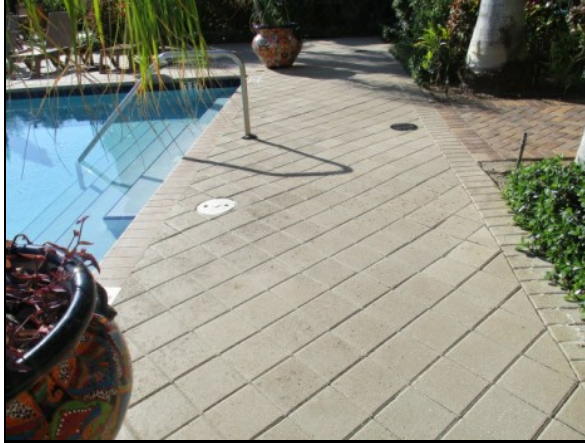
Useful Life:  
30 years

Remaining Life:  
12 years

Best Case: \$ 14,300

Worst Case: \$ 17,500

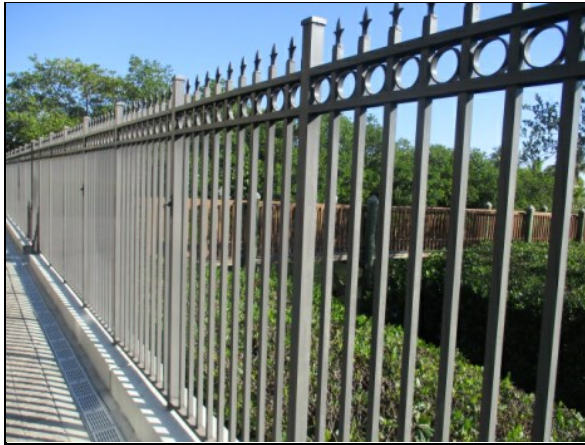
Useful Life:  
20 years

Remaining Life:  
10 years

Best Case: \$ 21,100

Worst Case: \$ 25,800

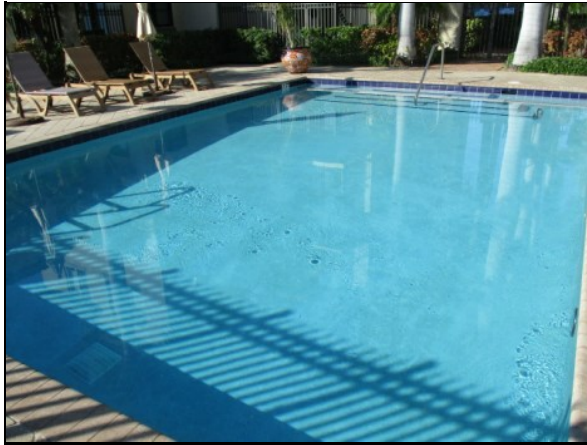
Useful Life:  
12 years

Remaining Life:  
6 years

Best Case: \$ 18,200

Worst Case: \$ 22,300

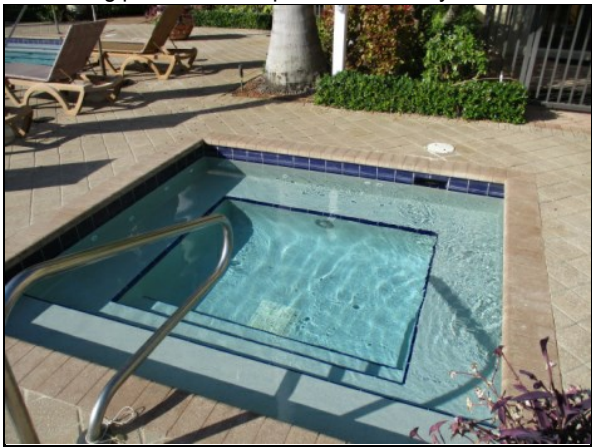
Useful Life:  
12 years

Remaining Life:  
6 years

Best Case: \$ 5,000

Worst Case: \$ 6,000

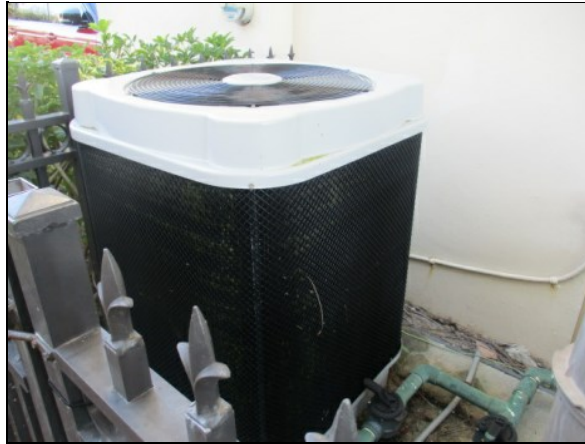
Useful Life:  
8 years

Remaining Life:  
4 years

Best Case: \$ 5,000

Worst Case: \$ 6,000

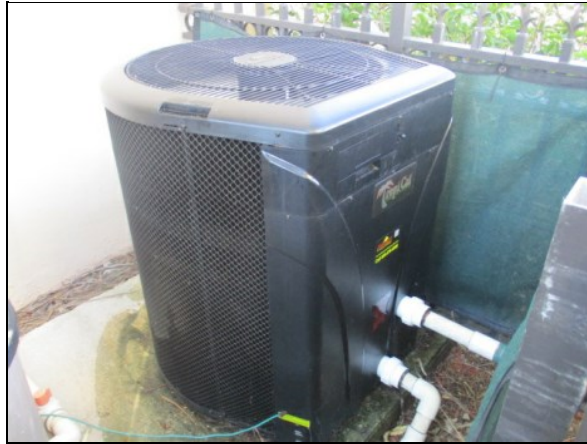
Useful Life:  
8 years

Remaining Life:  
5 years

Best Case: \$ 6,000

Worst Case: \$ 8,000

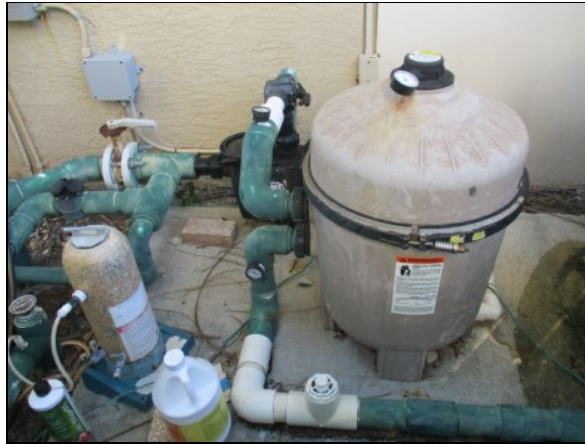
Useful Life:  
5 years

Remaining Life:  
2 years

Best Case: \$ 5,400

Worst Case: \$ 6,600
