RESIDENTIAL REPORT

Fairway O

4735 Lucerne Lakes

Phase One Milestone Inspection

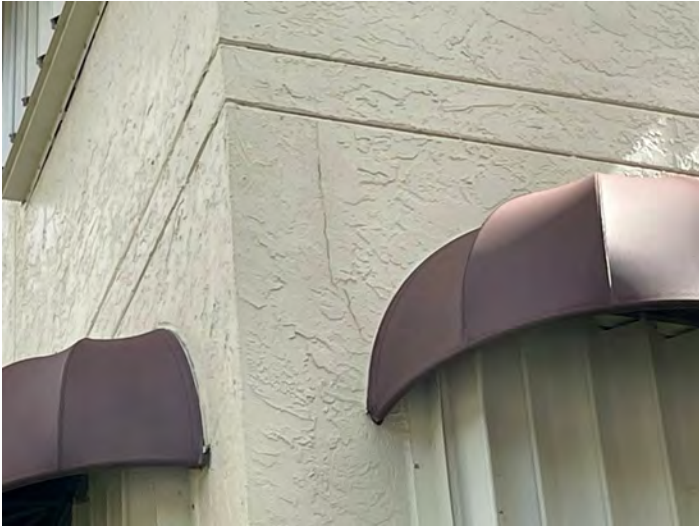
Item 1.o.1

1. Minor cracks in the wall left of the window on the second floor.
2. Crack/ spalling on back top next to gutter downspout needs repaired.
3. Recommend to clean the roof drains in the middle of the roof toward the front and the scuppers all around the parapet walls, to maintain proper rain water flow.

Only minor cracks on left wall to the left of the window on 2nd floor.

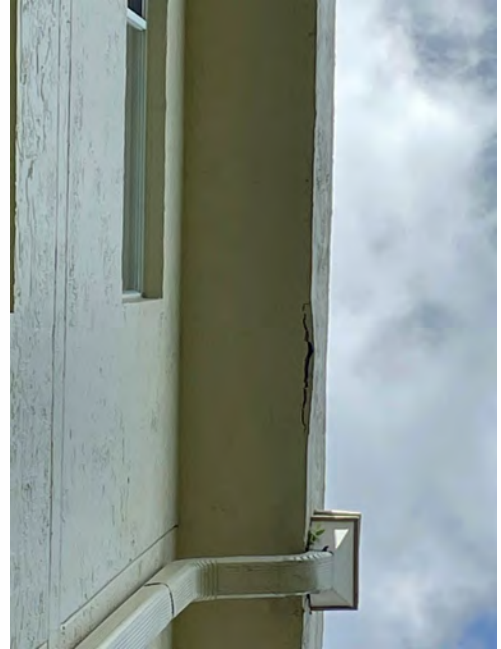
Item 1.o.2

Crack at the bottom of parapet wall in the back.

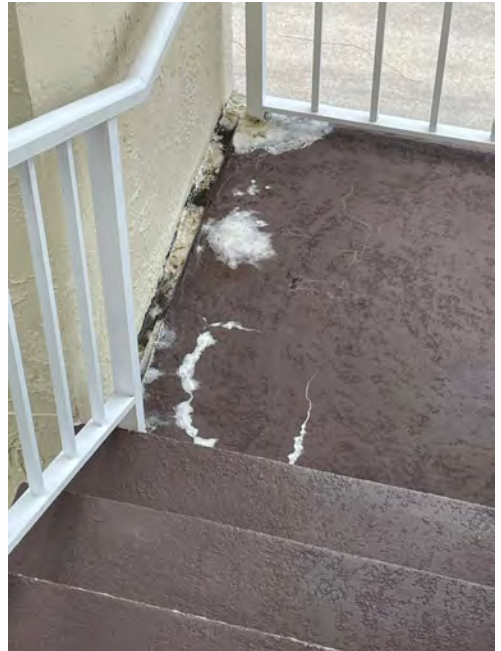
Item 1.o.4

4. Clean and repair/paint the bottom of the access stair at the roof access area.
5. Repair minor cracks at the bottom and at the top of the furring walls adjacent to concrete column near the elevator.

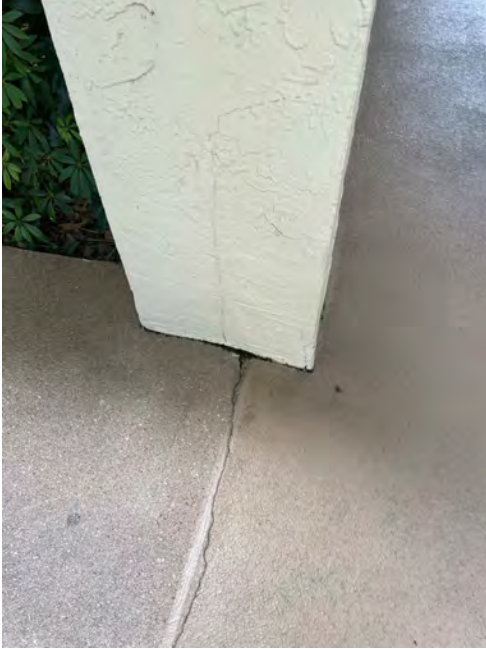
Item 1.o.5

Minor cracks toward the bottom and toward the top of column near the elevator, in wall furrings.

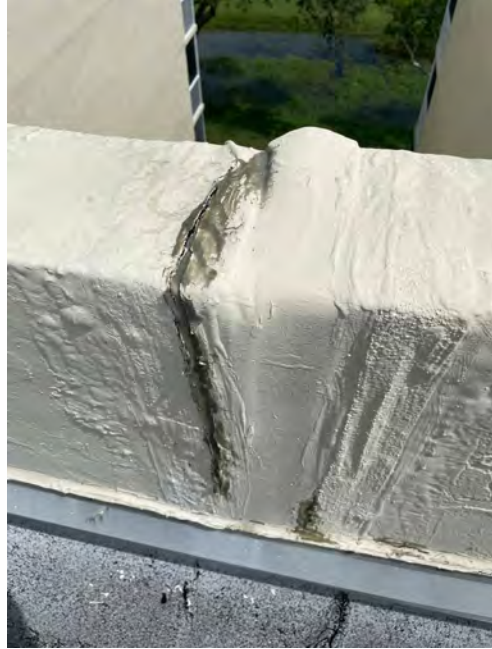
Item 1.o.6

6. Repair/ seal crack at control joint on roof parapet wall.
7. Repair hand rail base connections to concrete in several areas.
p. Required (describe and indicate acceptance)
The visible cracks should be eliminated and review and acceptance by County inspector or professional engineer is not required.
