## STRUCTURAL INTEGRITY RESERVE STUDY

### Fairway O

4735 Lucerne Lakes Boulevard East  
Lake Worth, Florida 33467

August 28, 2023

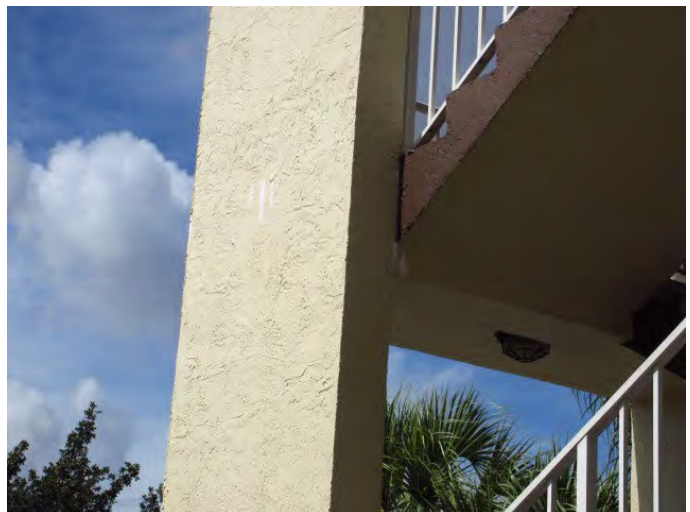
**PHOTO 18**

MINOR EFFLORESCENCE ON FAÇADE

Item No.	Item Description	Quantity	Unit	Cost	Totals	Existing Banalce	Remaining Funds	Comments
1	Exterior façade elements	1	LS	\$12,000.00	\$12,000			Repair / seal stucco crack and efflorescence check-coat
2	Roof	1	LS	\$5,000.00	\$5,000			Repair failing roof areas
					<b>Subtotal</b>	<b>\$144,711.00</b>	<b>\$127,711.00</b>	
		<b>Total Immediate Repairs</b>			<b>\$17,000</b>			
			<b>Cost Per Unit</b>		<b>\$265.63</b>

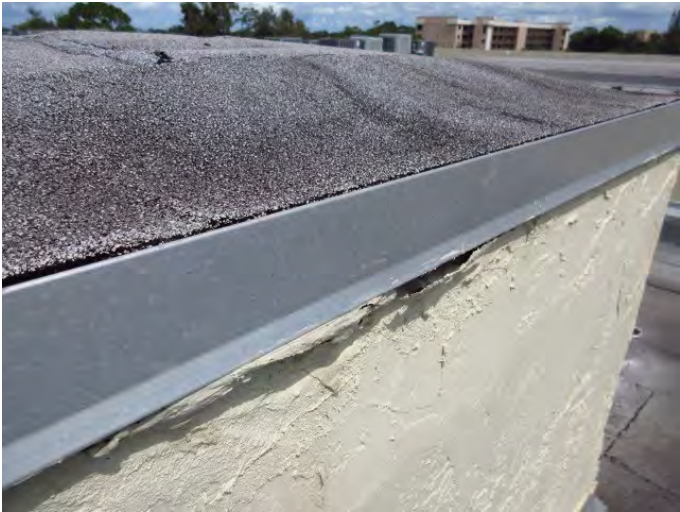
**PHOTO 19**

VIEW OF DAMAGED EXTERIOR WALL

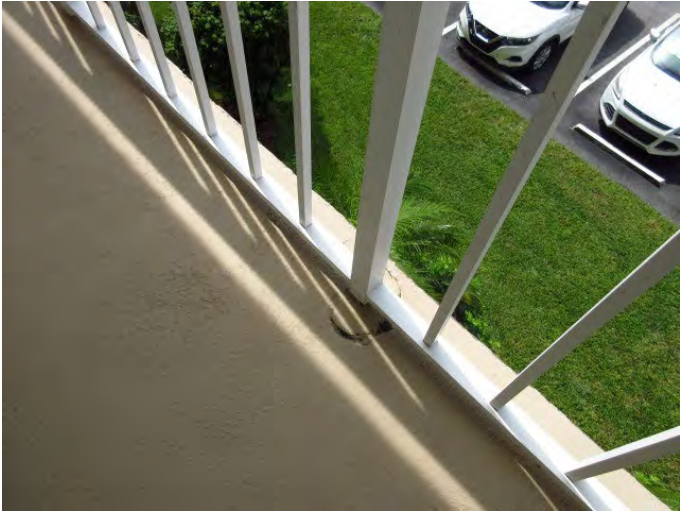
**PHOTO 20**

DAMAGED UPPER-LEVEL WALKWAY SLAB AT RAILING

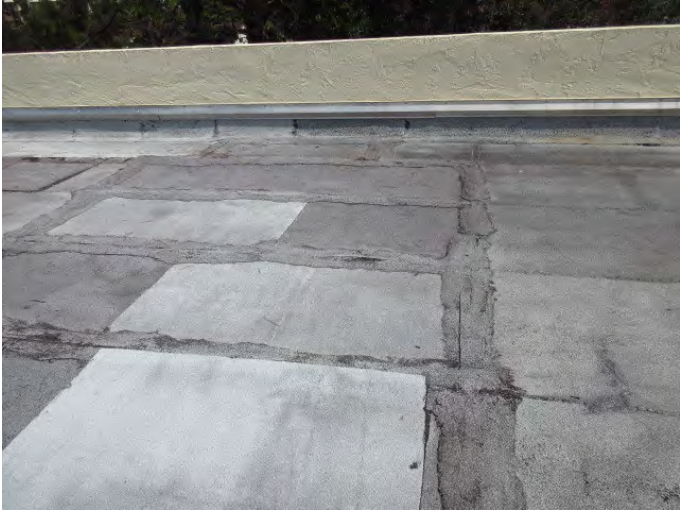
**PHOTO 21**

VIEW OF FAILING ROOF MEMBRANE
