Inlet Harbor Club C.A., Inc.
Boynton Beach, FL

Report #: 48071-0
Beginning: January 1, 2024
Expires: December 31, 2024

RESERVE STUDY
"Full"

June 2, 2023

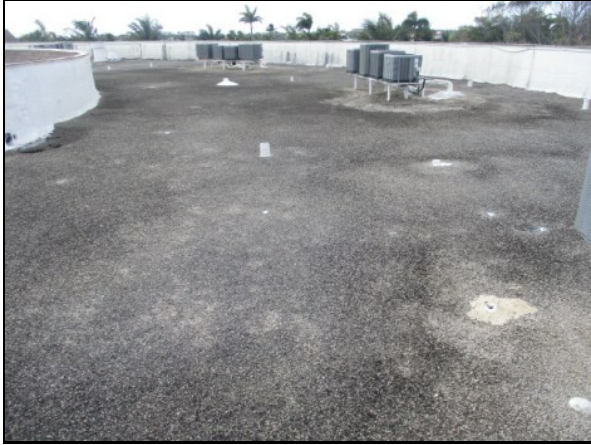
Useful Life:
25 years

Remaining Life:
2 years

Lower estimate to replace

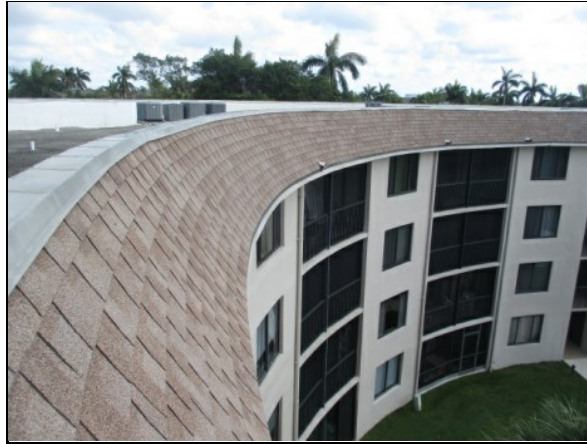
Useful Life:
25 years

Remaining Life:
7 years

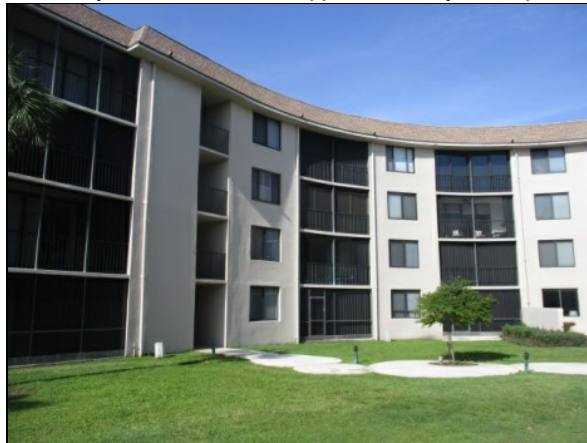
Useful Life:
10 years

Remaining Life:
2 years

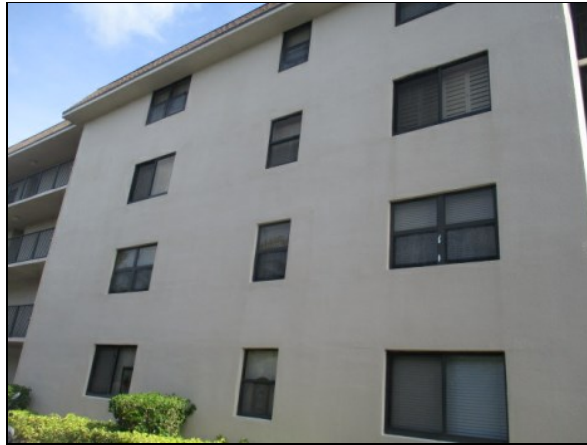
Useful Life:
10 years

Remaining Life:
2 years

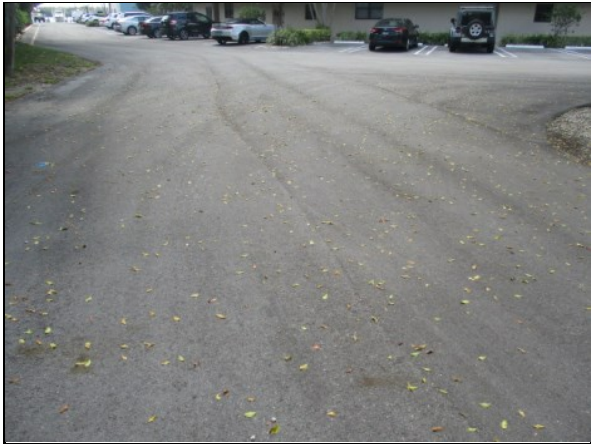
Useful Life:
4 years

Remaining Life:
0 years

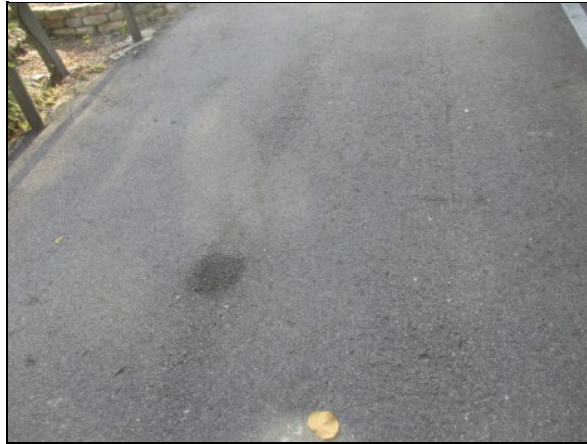
Useful Life:
20 years

Remaining Life:
14 years

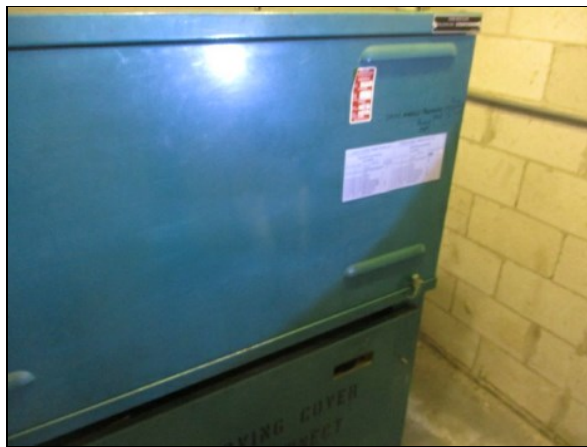
Useful Life:
25 years

Remaining Life:
0 years

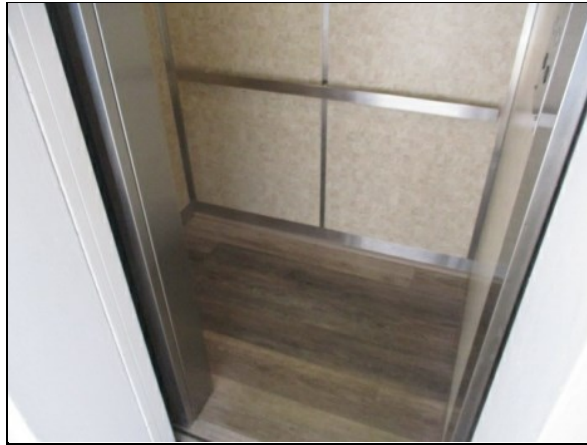
Useful Life:
25 years

Remaining Life:
0 years

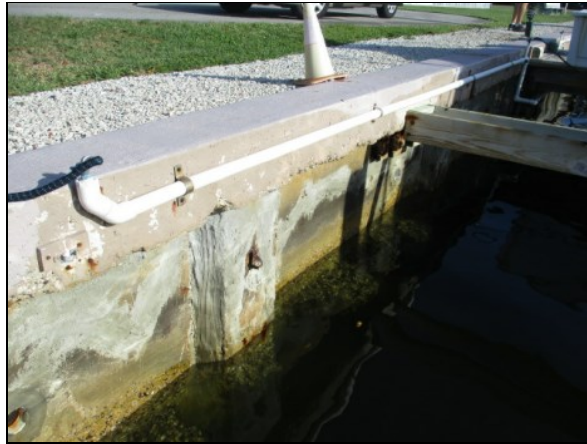
Useful Life:
50 years

Remaining Life:
18 years

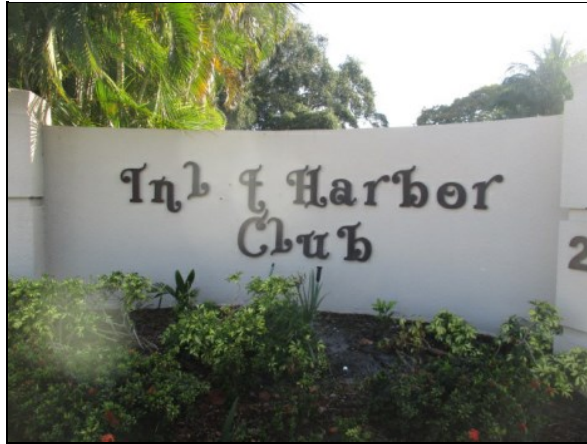
Useful Life:
20 years

Remaining Life:
0 years

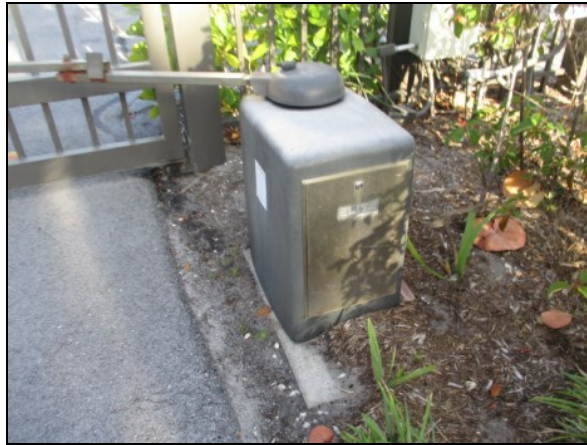
Useful Life:
15 years

Remaining Life:
0 years

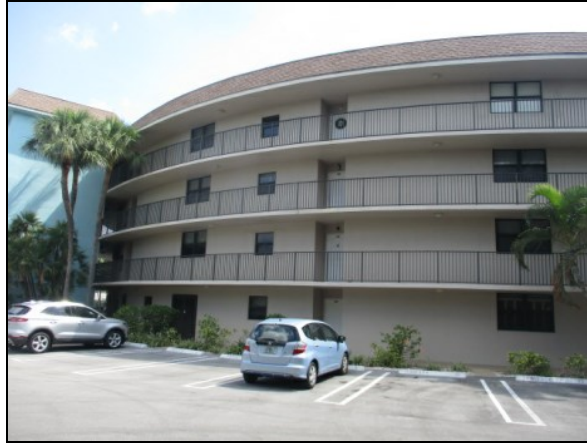
Useful Life:
1 years

Remaining Life:
0 years

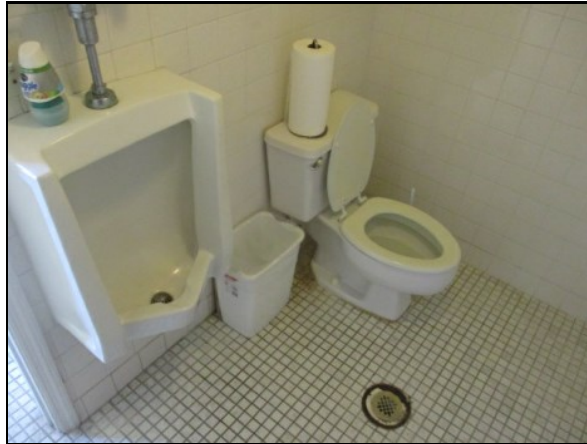
Useful Life:
20 years

Remaining Life:
0 years

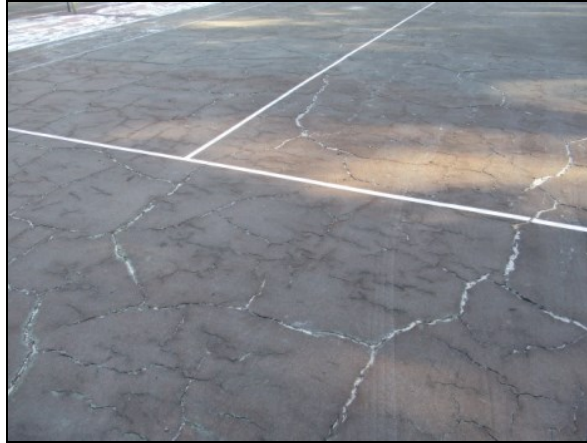
Useful Life:
30 years

Remaining Life:
0 years
