Client: Grand Isles Condominium

Address: 4195 Haverhill Rd

Uniform Mitigation Verification Inspection Form

Inspection Date: 04/11/2024		
Owner Information		
Owner Name: Grand Isles Condominium		Contact Person:
Address: 4195 Haverhill Rd		Home Phone:
City: West Palm Beach	Zip: 33417	Work Phone:
County: Palm Beach		Cell Phone:
Insurance Company:		Policy #:
Year of Home: 2000	# of Stories:	Email:

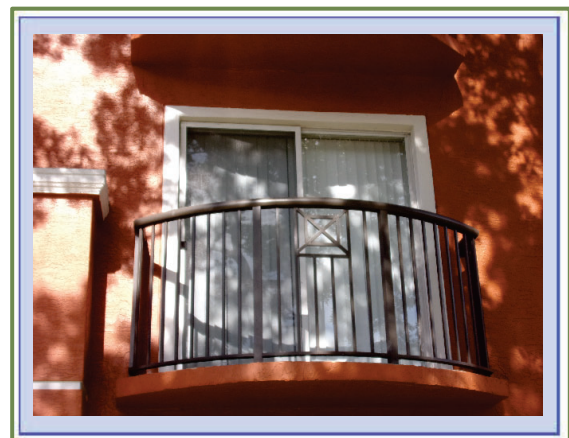
Unprotected Opening

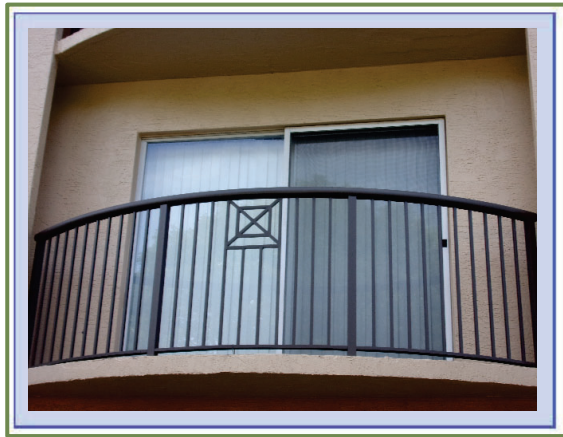
Unprotected Opening

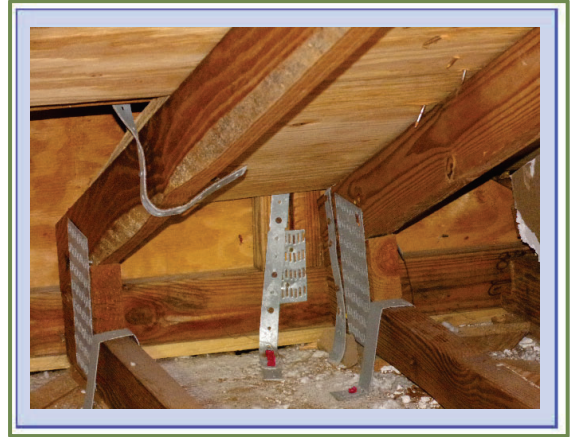
- ☒ B. Clips
- ☒ Metal connectors that do not wrap over the top of the truss/rafter, **or**
- ☐ Metal connectors with a minimum of 1 strap that wraps over the top of the truss/rafter and does not meet the nail position requirements of C or D, but is secured with a minimum of 3 nails.

Clip

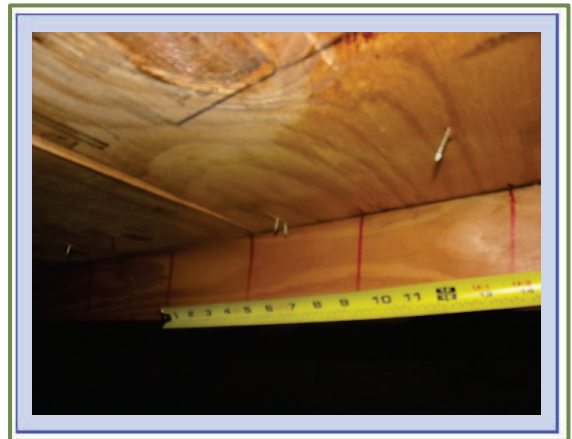
☒ C. Plywood/OSB roof sheathing with a minimum thickness of 7/16" inch attached to the roof truss/rafter (spaced a maximum of 24" inches o.c.) by 8d common nails spaced a maximum of 6" inches in the field. -OR- Dimensional lumber/Tongue & Groove decking with a minimum of 2 nails per board (or 1 nail per board if each board is equal to or less than 6 inches in width). -OR- Any system of screws, nails, adhesives, other deck fastening system or truss/rafter spacing that is shown to have an equivalent

6x6 nail spacing
