Uniform Mitigation Verification Inspection Form

Inspection Date: 07/15/2024		
Owner Information		
Owner Name: Atlantic Grove Townhome Association Inc.		Contact Person:
Address: 316-336 Atlantic Grove Way		Home Phone:
City: Deerfield Beach	Zip: 33444	Work Phone:
County: Palm Beach		Cell Phone:
Insurance Company:		Policy #:
Year of Home: 2003	# of Stories: 3	Email:

Inspectors Initials DB **Property Address** 316-336 Atlantic Grove Way, Deerfield Beach, FL 33444

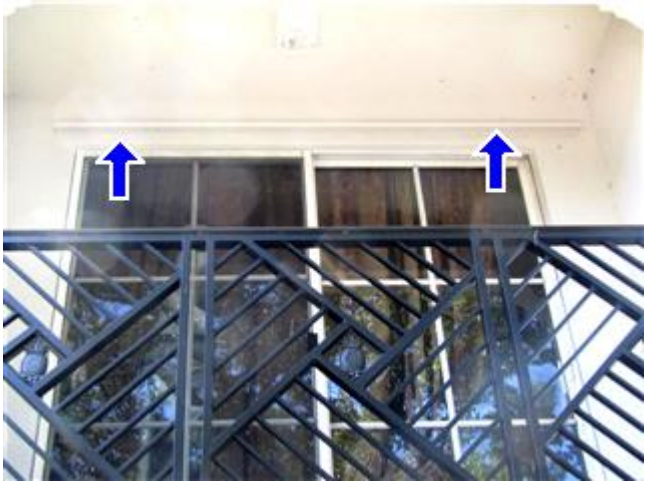
Hurricane Shutter Hardware - Glass Doors

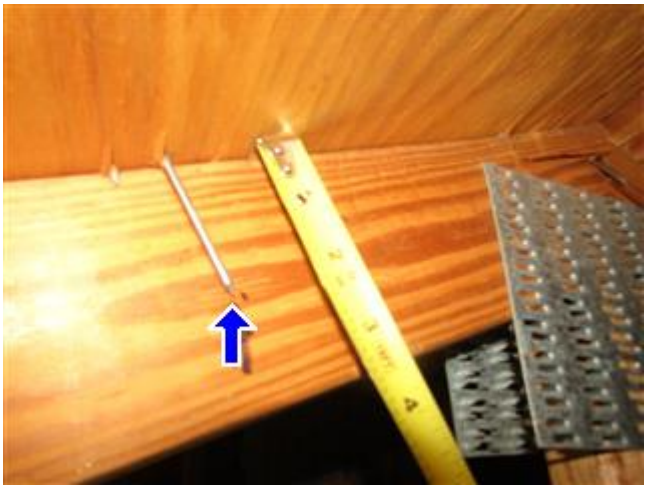
Roof to Deck Connection - 8D Nailing
