Uniform Mitigation Verification Inspection Form

Inspection Date: 07/15/2024		
Owner Information		
Owner Name: Atlantic Grove Townhome Association Inc.		Contact Person:
Address: 71-83 Atlantic Grove Way		Home Phone:
City: Delray Beach	Zip: 33444	Work Phone:
County: Palm Beach		Cell Phone:
Insurance Company:		Policy #:
Year of Home: 2003	# of Stories: 3	Email:

Inspectors Initials DB **Property Address** 71-83 Atlantic Grove Way, Delray Beach, FL 33444

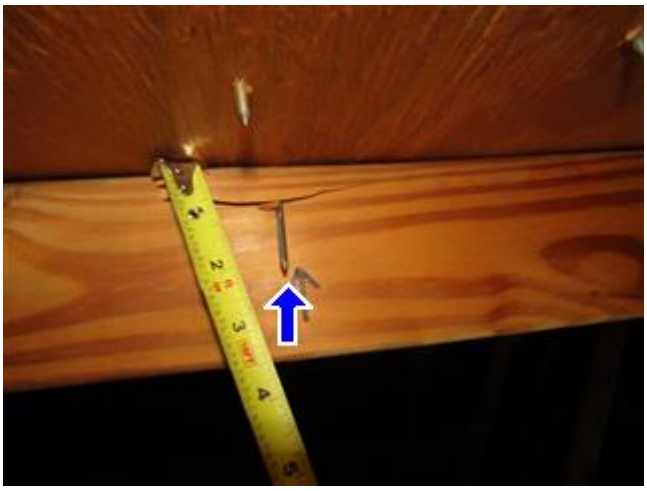
- ☑ C. Plywood/OSB roof sheathing with a minimum thickness of 7/16"inch attached to the roof truss/rafter (spaced a maximum of 24"inches o.c.) by 8d common nails spaced a maximum of 6" inches in the field. -OR- Dimensional lumber/Tongue & Groove decking with a minimum of 2 nails per board (or 1 nail per board if each board is equal to or less than 6 inches in width). -OR- Any system of screws, nails, adhesives, other deck fastening system or truss/rafter spacing that is shown to have an equivalent

Roof to Deck Connection - 8D Nailing

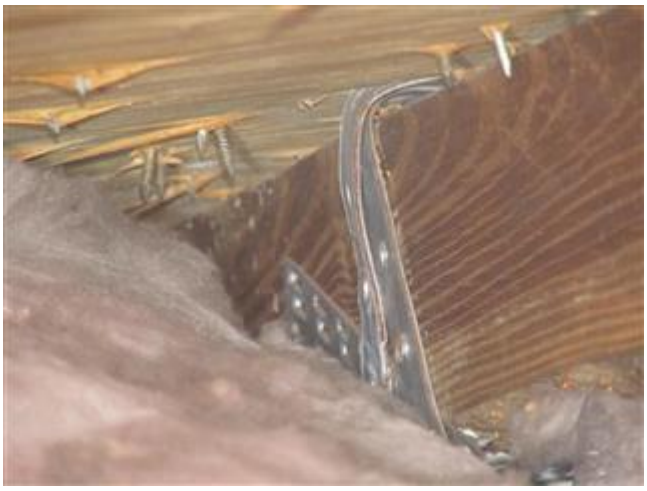
- ☑ D. Double Wraps
     - ☑ Metal Connectors consisting of 2 separate straps that are attached to the wall frame, or embedded in the bond beam, on either side of the truss/rafter where each strap wraps over the top of the truss/rafter and is secured with a minimum of 2 nails on the front side, and a minimum of 1 nail on the opposing side, **or**

Roof to Wall Connection - Double Straps
