Inlet Harbor Club C.A., Inc.
Boynton Beach, FL

Report #: 48071-0
Beginning: January 1, 2024
Expires: December 31, 2024

RESERVE STUDY
"Full"

June 2, 2023

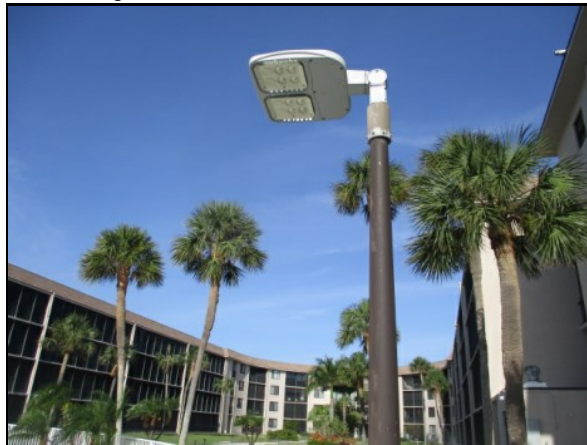
Comp #: 2772 Pool Deck Lights - Replace

Fair condition: Pool deck lights determined to be in fair condition typically exhibit somewhat faded/worn appearance but overall assembly is sturdy and aging normally. Serviceable physical condition and still appropriate for aesthetic standards.

Lighting around the pool deck should be inspected regularly to ensure adequate brightness at night for safety. Replacement is often coordinated with other exterior or site lighting, or with pool fence or other components in this area. Cost shown are based on replacement with comparable size and design standards.

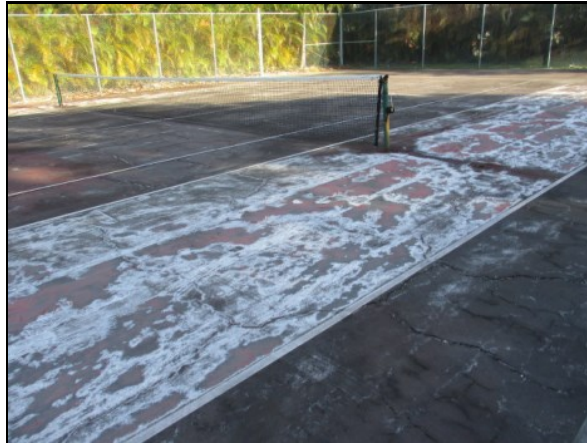
History: We recommend complete rebuild of tennis courts - On this basis, remaining useful life of future coat offset until AFTER complete rebuilding of courts.

Comments: Poor condition: Tennis courts determined to be in poor condition typically exhibit moderate to advanced surface wear and deterioration and typically include at least some significant cracking. At this stage drainage concerns may be a problem and there may be some impediments to play.

Inspect courts regularly and locally repair as needed within the annual Operating budget. Cracks and trip hazards should be addressed promptly to ensure safety. Re-coating is a recommended practice for restoring appearance of the court, bridging small surface cracks, and prolonging the life of the court surface itself. Plan to re-coat (includes striping) at the approximate interval shown below. Maintenance projects such as pressure-washing should be considered as Operating expense.
