# **PHASE 1 MILESTONE REPORT**

## **THE SENATE CONDOMINIUM**

**2500 PRESIDENTIAL Way**

**MILESTONE INSPECTION REPORT**

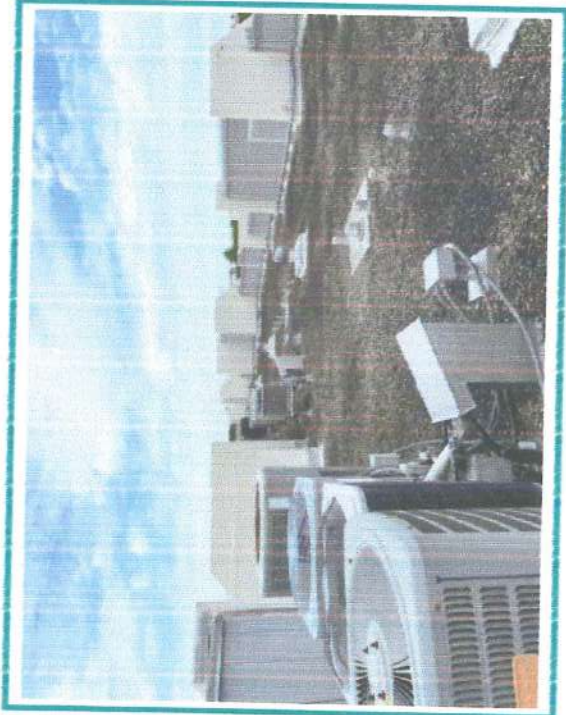
1. Overview of roof (2500 Bldg) looking W. from SE. corner

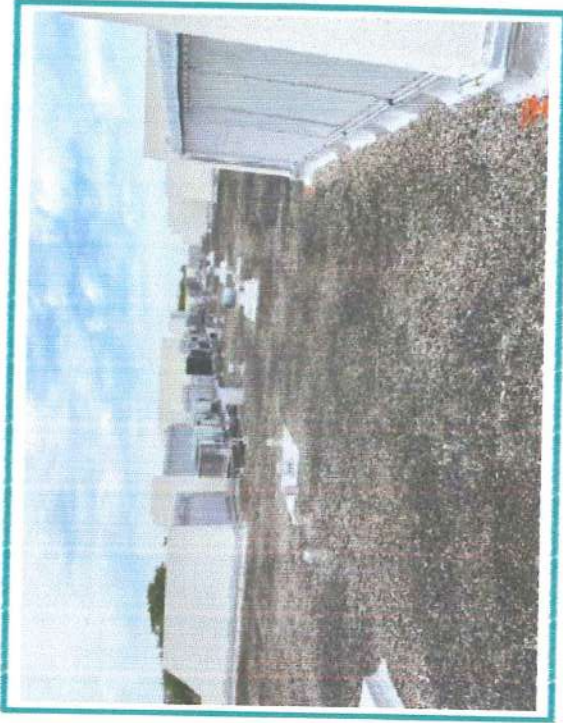
2. Overview of roof (2500 Bldg) looking W. from NE. corner

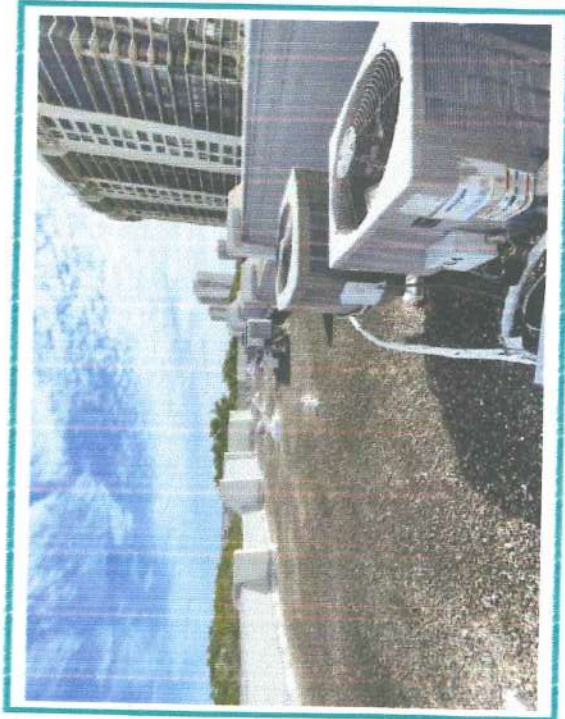
3. Overview of roof (2500 Bldg) looking E. from S. center

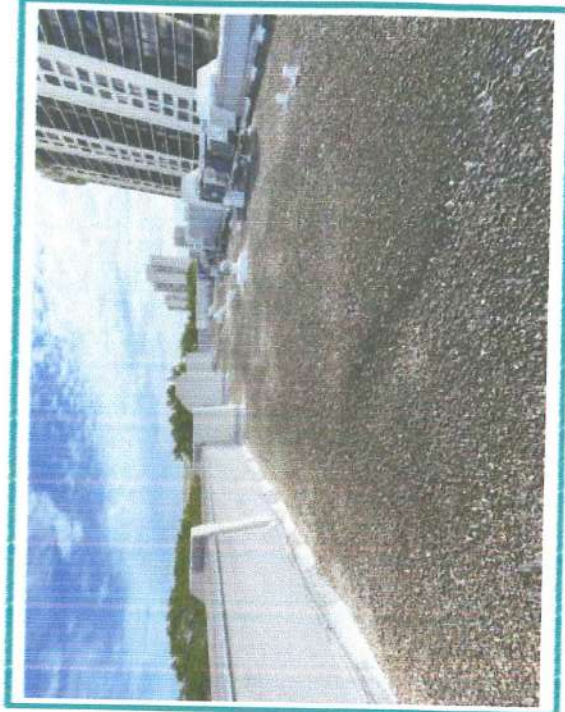
4. Overview of roof (2500 Bldg) looking E. from N. center

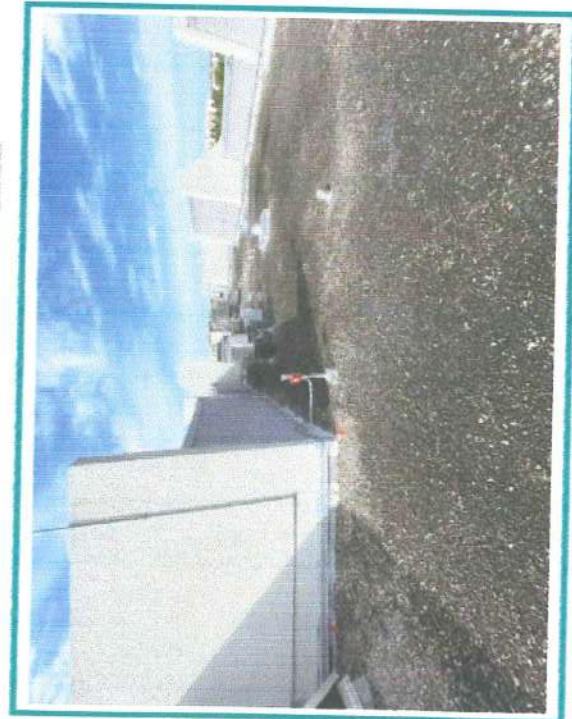
5. Overview of roof (2500 Bldg) looking W. from S. center

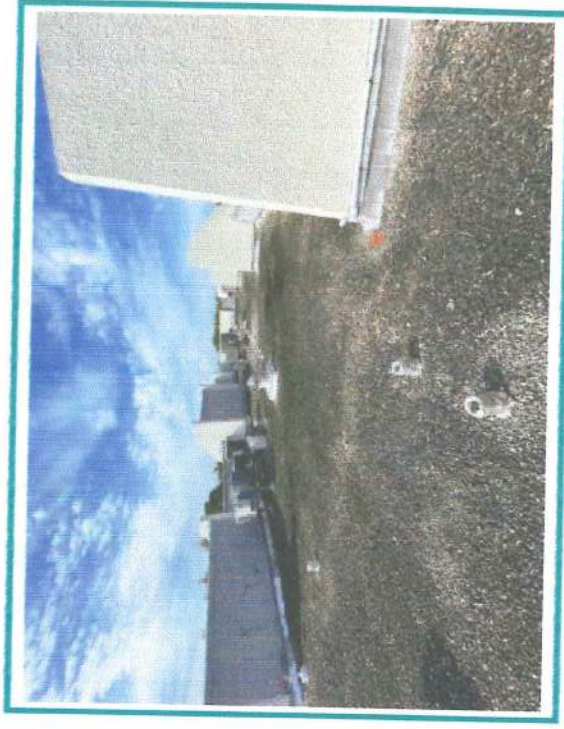
6. Overview of roof (2500 Bldg) looking W. from N. center

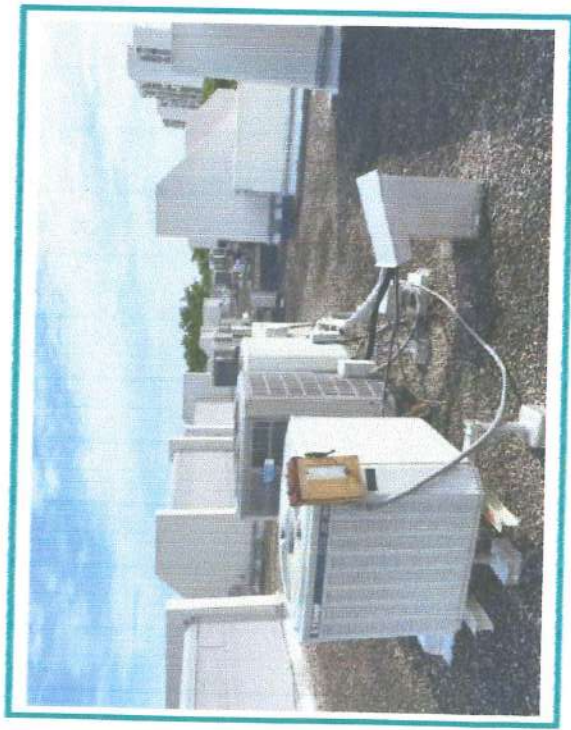
7. Overview of roof (2500 Bldg) looking E. from SW. corner

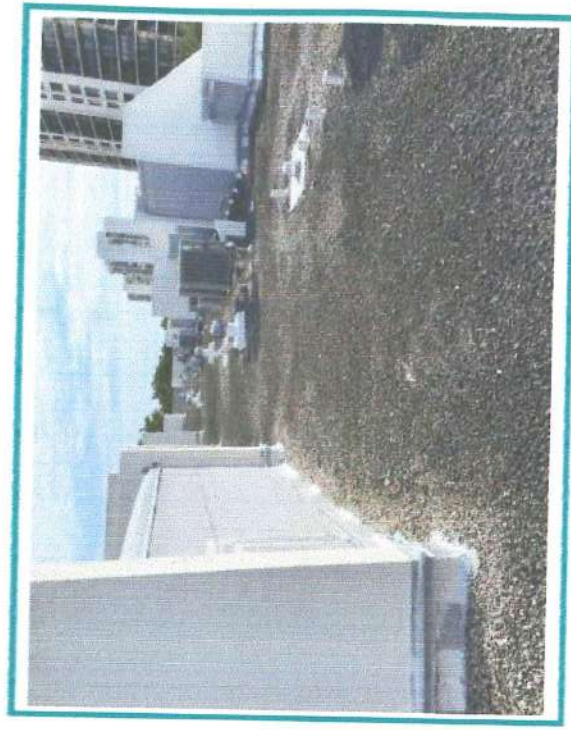
8. Overview of roof (2500 Bldg) looking E. from SW. corner
