# PHASE 1 MILESTONE REPORT

## SENATE CONDOMINIUM

**3050 PRESIDENTIAL WAY**

**MILESTONE INSPECTION REPORT**

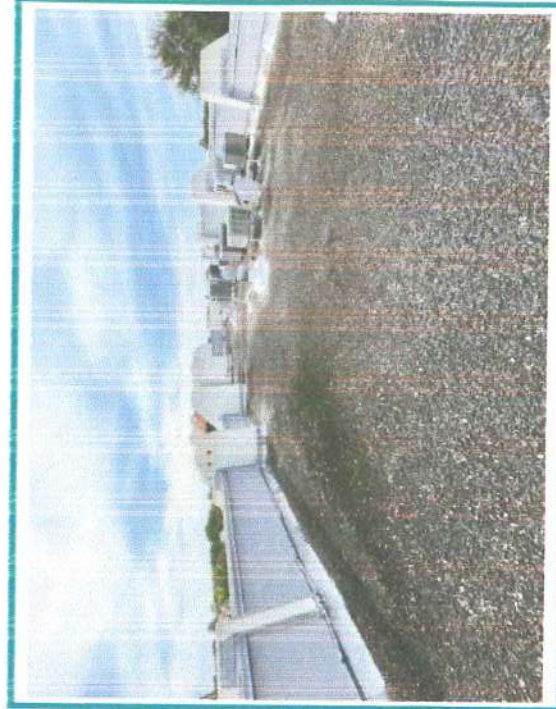
3. Overview of roof (3050 Bldg) looking NE. from E. center

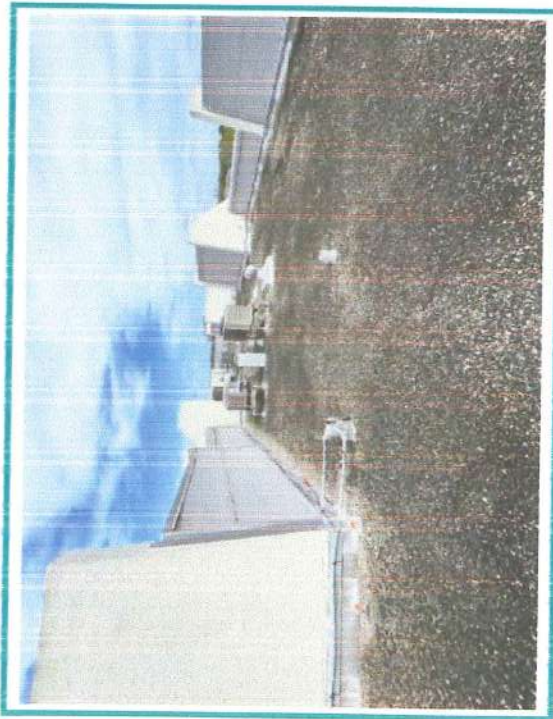
4. Overview of roof (3050 Bldg) looking NE. from W. center

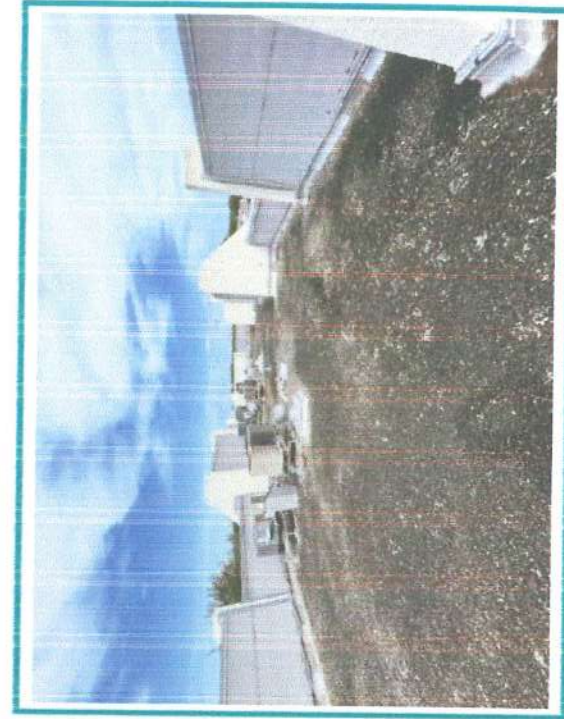
5. Overview of roof (3050 Bldg) looking SE. from E. center

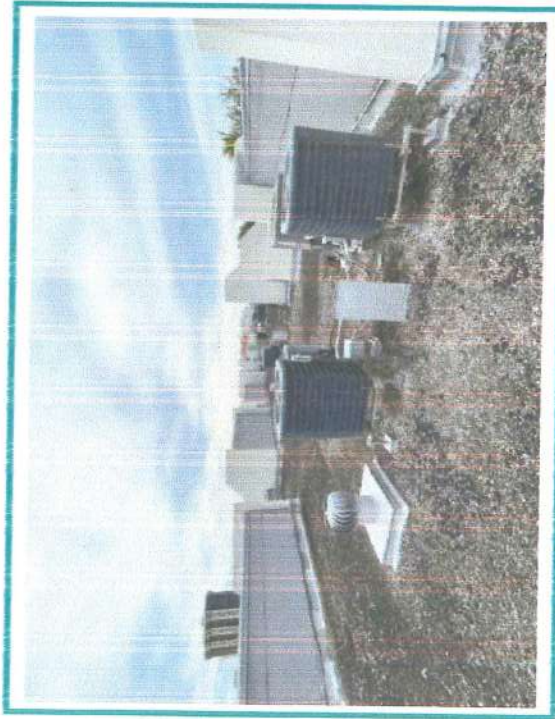
6. Overview of roof (3050 Bldg) looking SE. from W. center
