# PHASE 1 MILESTONE REPORT

## SENATE CONDOMINIUM

**3050 PRESIDENTIAL WAY**

**MILESTONE INSPECTION REPORT**

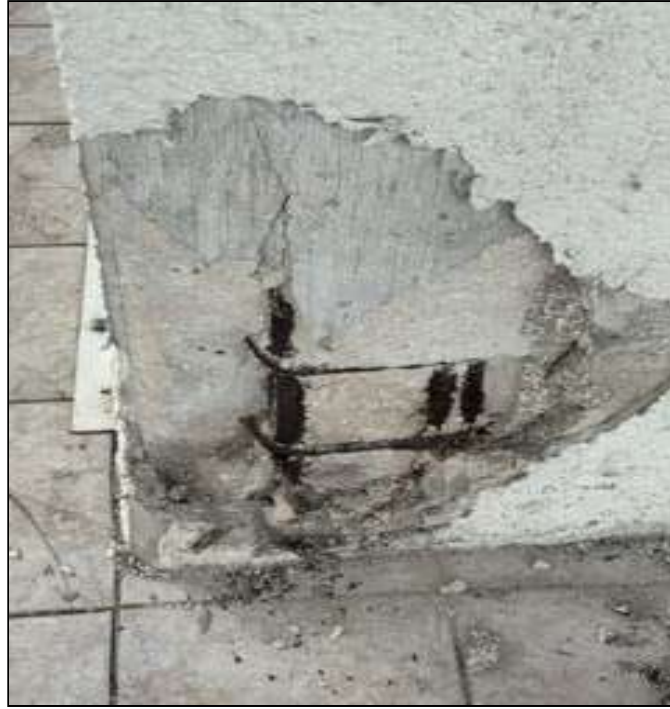
**WALL REPAIR UNIT 201 ( EAST & NORTH SIDES )**
